# Planning Submission

## Housing Land Supply Act

### Preservation Drive, Sulphur Creek

The following submission has been prepared by All Urban Planning Pty Ltd for Homes Tasmania in support of a housing land supply order under the *Housing Land Supply Act 2018* (HLSA). The proposed order is to rezone an area of land (the subject land) at Sulphur Creek, adjacent to the Howth roundabout from Utilities zoning to General Residential under the *Tasmanian Planning Scheme – Central Coast Local Provisions Schedule (planning scheme)*.

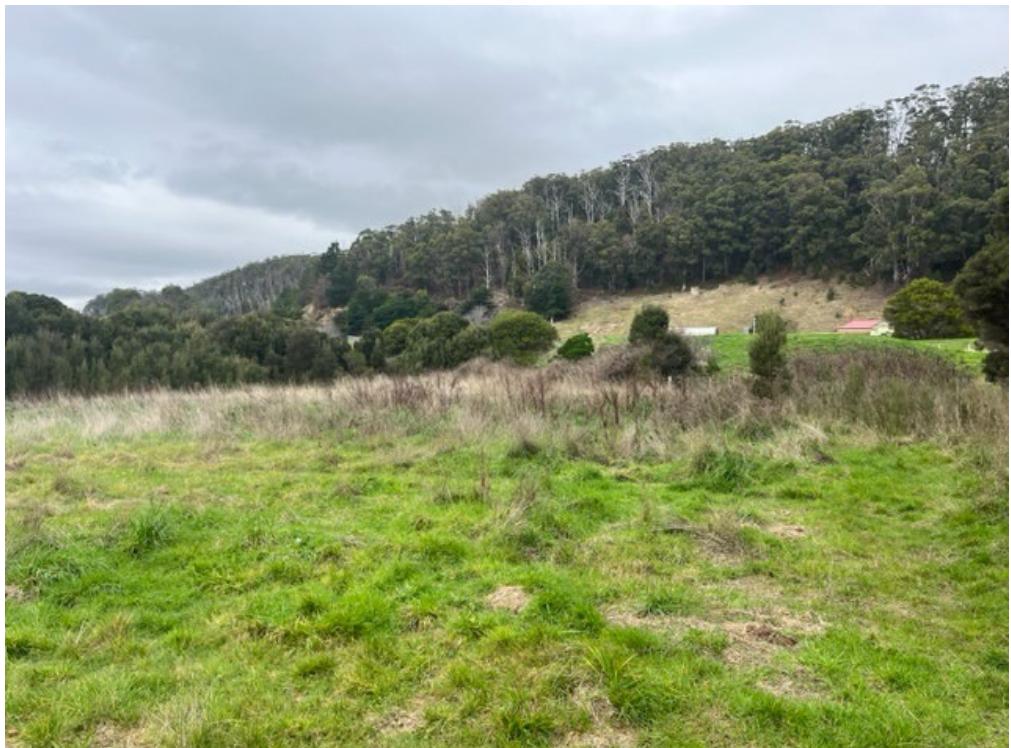
*Figure 9 –View looking south east on Parcel 1. An earthen berm separating the site from the Bass Highway is visible on the right of picture. The house with the red roof is on the opposite/southern side of Bass Highway.*

In relation to the setback to the Bass Highway, there is an existing earthen berm along the southern side of Parcel 2 (Figure 14) and the eastern side of the southern boundary of Parcel 1 (Figure 9). The Bass Highway is in a significant cut adjacent to the rear of Parcel 3 (Figure 21). These characteristics would appear to provide effective mitigation from highway noise to the majority of the subject land.

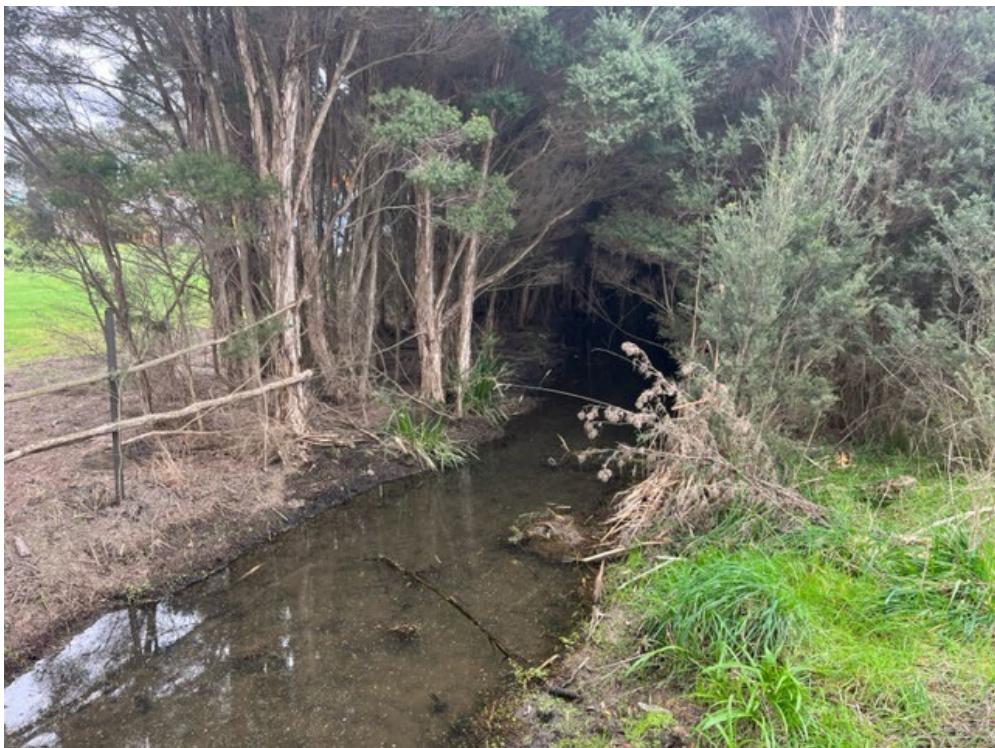
*Figure 10 – view from inside the Preservation Drive frontage of Parcel A looking south showing the existing open drainage channel that runs north south through Parcel A.*

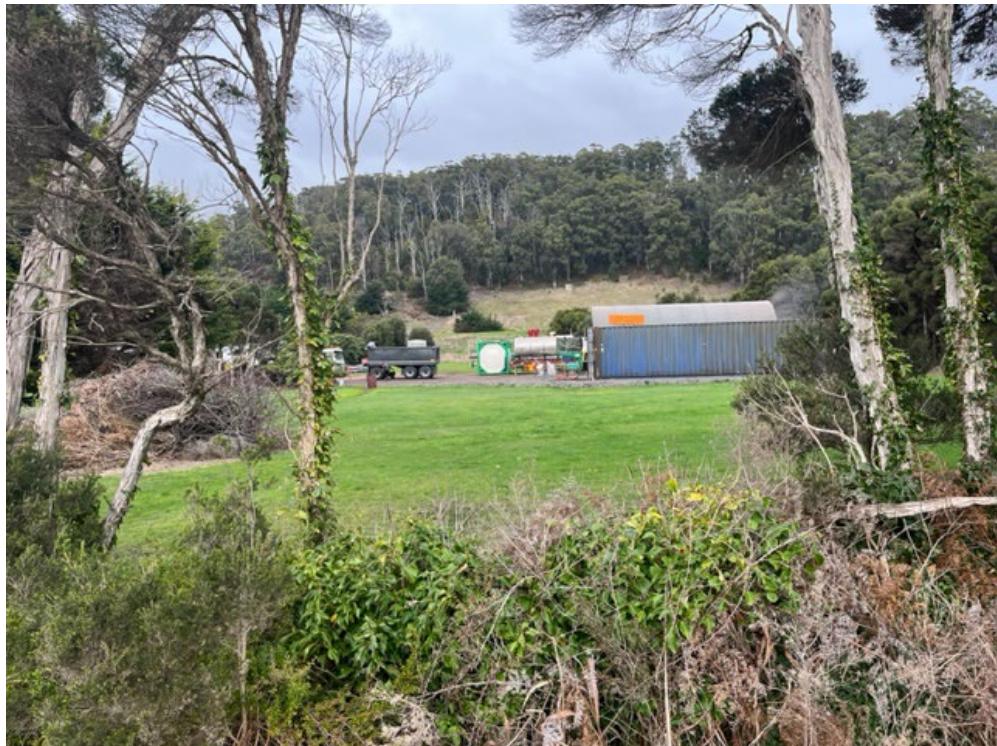
*Figure 12 – View from the Preservation drive frontage towards the eastern end of Parcel 1 looking south. The existing truck wash bay associated with the truck repair garage at 2 Lyle Street is visible in the midground.*

The subject land is vacant other than an existing truck storage and maintenance activity (see Figure 12) and lies between the Bass Highway and Preservation Drive.

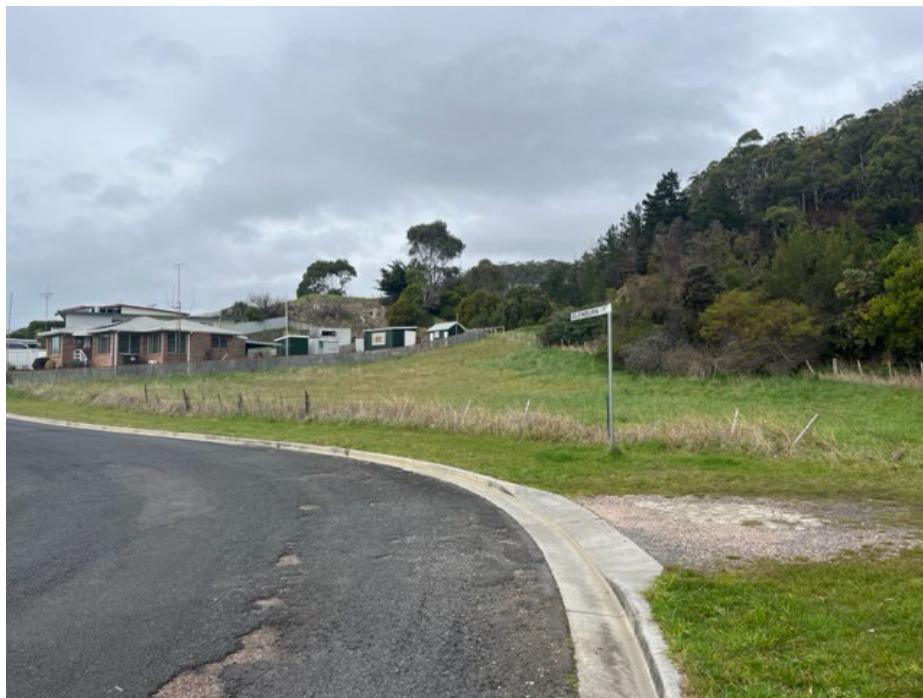
*Figure 13 – View of the existing truck repair garage, Dazeley Engineering at 2 Lyle Street looking north west. The existing truck wash on Parcel 1 (see Figure 12) is an extension of this business.*

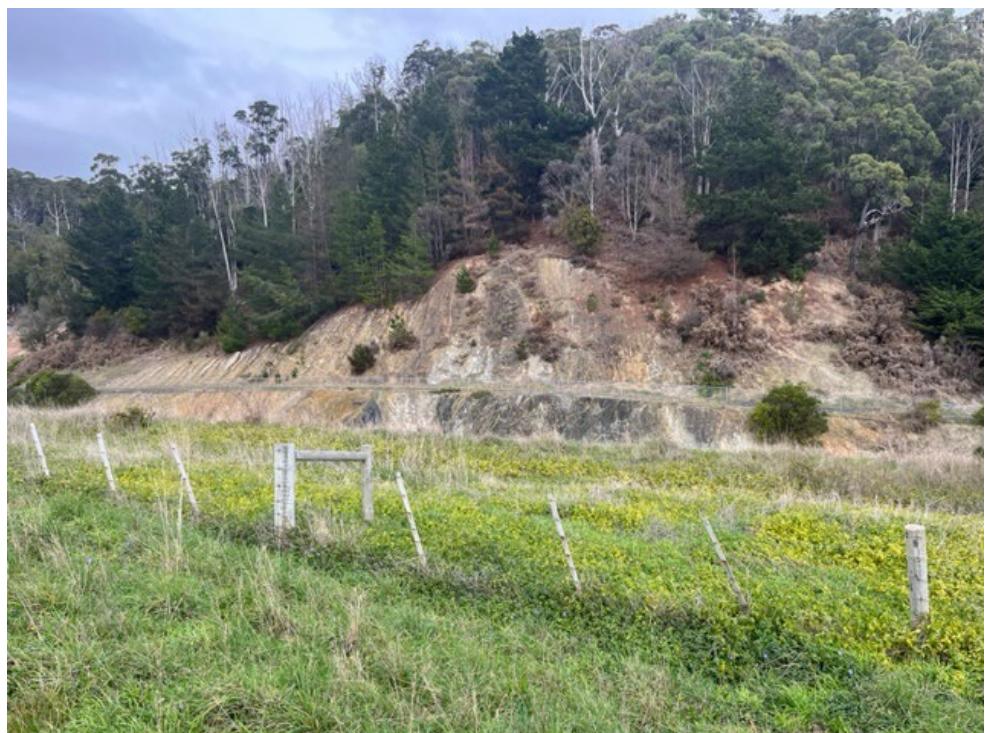
*Figure 21 – View looking south from the top of Parcel 3. The Bass Highway formation is in significant cut at this location and well below the existing ground level of Parcel 3.*

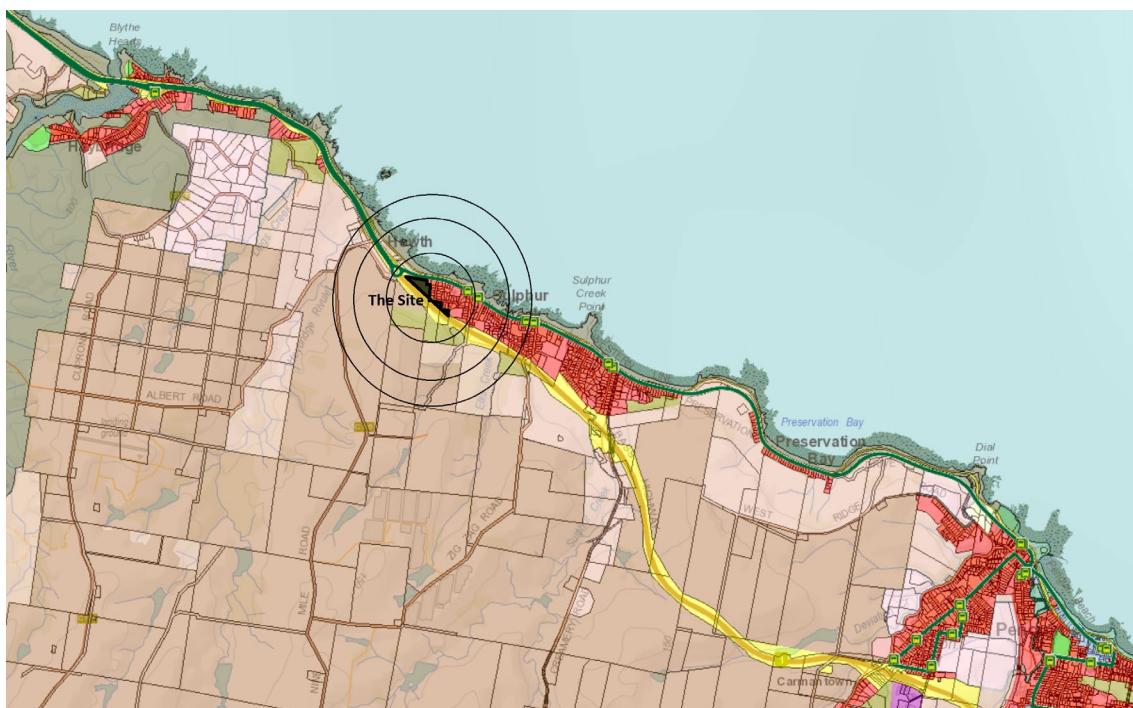
**Figure 27 - The site is located on Metro bus route 190 that runs between Burnie, Penguin and Ulverstone past the Preservation Road frontage of the subject land (Source: theList)**

The Metro, public transport bus route 190 passes the site on Preservation Drive to the north (See Figure 27 below). This route travels between Ulverstone and Burnie with 5 trips between 7.30am and 5pm Monday to Friday and two services at 10.30am and 2pm Saturday.

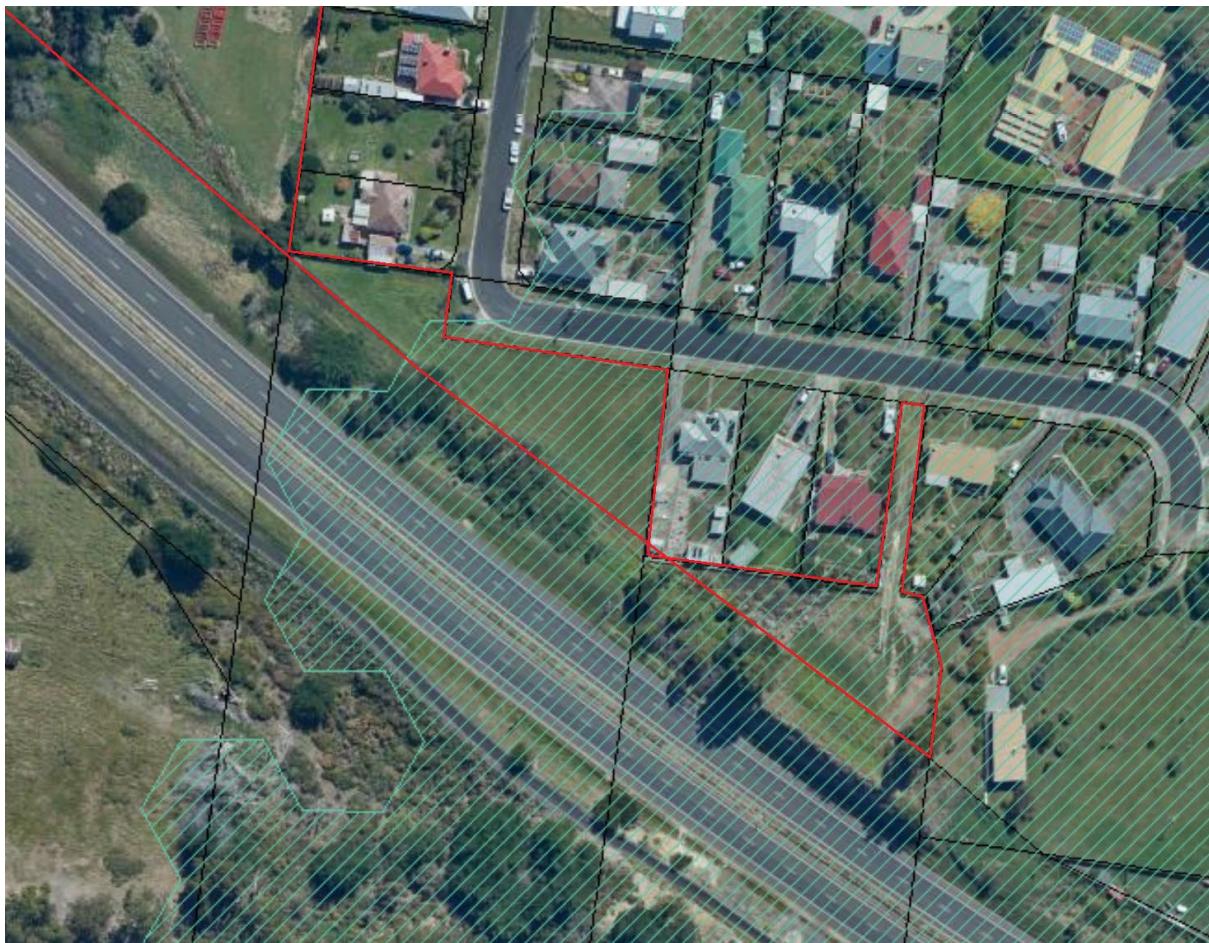
The C7.0 Natural Assets Code (Priority Vegetation Area) applies to approximately 0.67 ha of Parcels 2 and 3 behind Glenburn Crescent as shown Figure 28.

**Figure 28 - Priority Vegetation Overlay (Source: theList Planning Scheme Code Overlay - Priority Vegetation)**

The accompanying Natural Values Assessment and letter from ECOTas, 23 December 2023 in Appendix D to this report confirms that there are no priority vegetation values that would prevent development of the land.

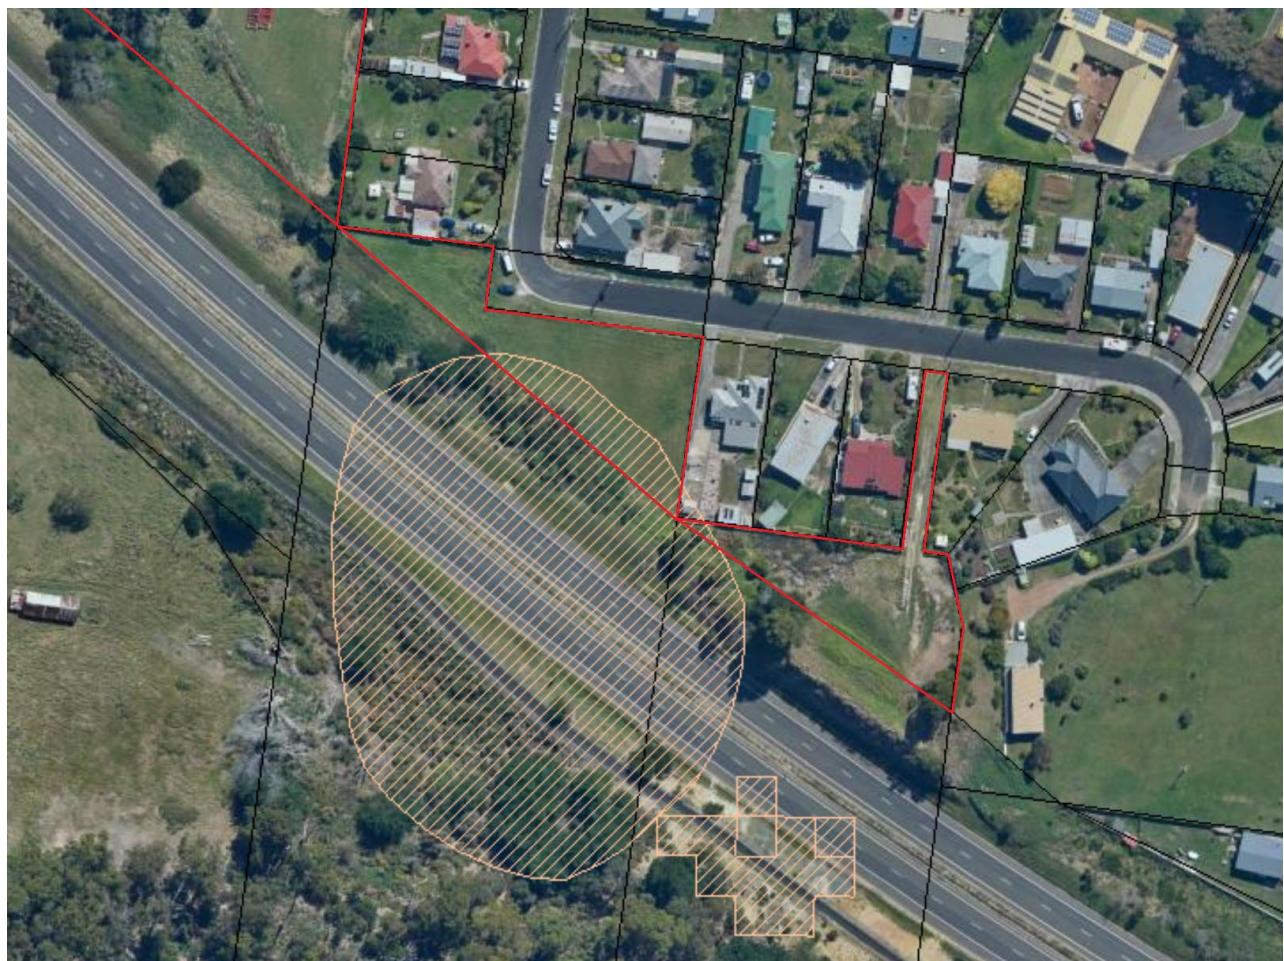
**Figure 29 -Mapped Medium Landslip Hazard Area (Source: theList – planning scheme code overlays)**

An area of Medium Landslip Hazard covers a portion of the southern embankment of Parcel 2 and a small corner of Parcel 3 as shown in Figure 29 below.

The accompanying Landslide Risk Assessment provided in Appendix E confirms that subject to appropriate hillside design, geotechnical investigation and footing design the landslide risk is low to very low. It is considered that these matters will be adequately addressed as part of a future subdivision application under the Landslip Hazard Code and with development specific geotechnical and engineering advice as part of subsequent work under the *Building Act 2016*.

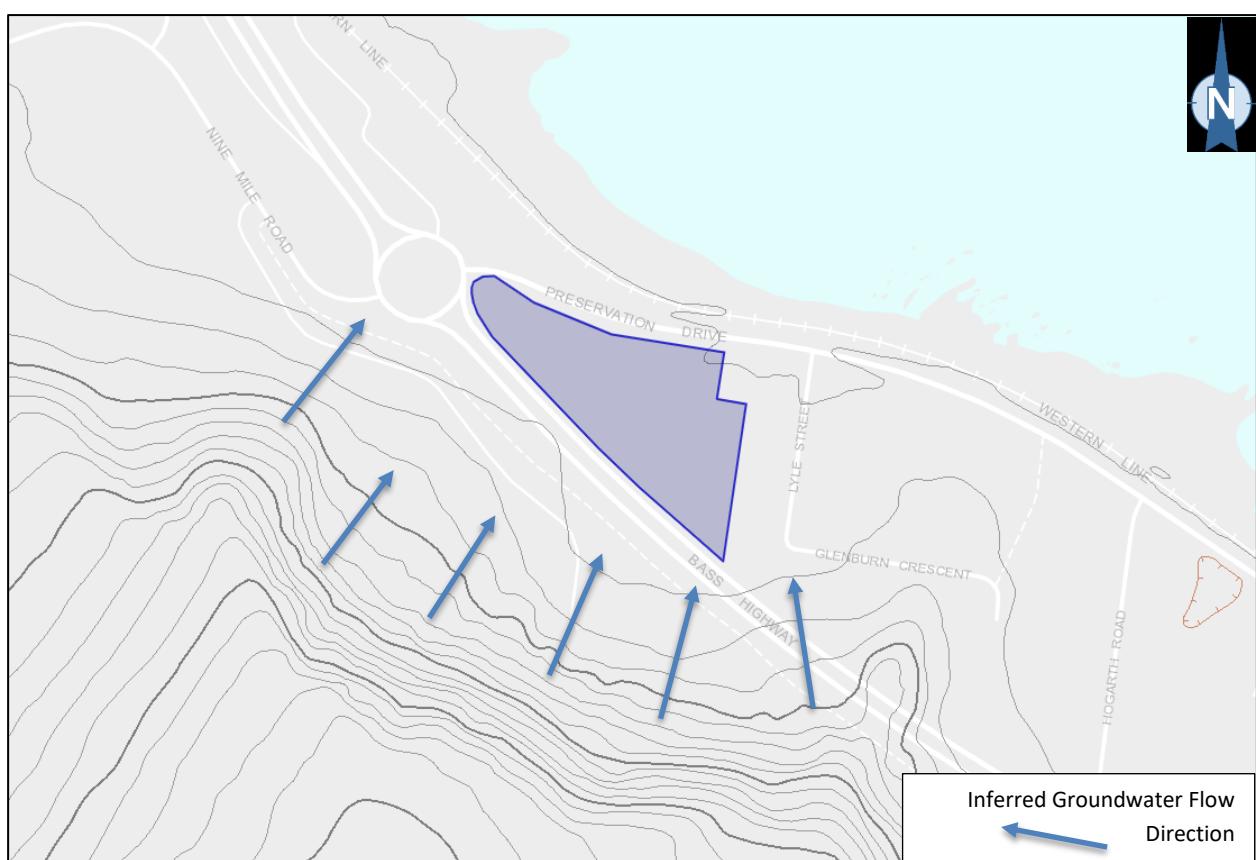
Figure 3: Inferred Groundwater Flow Direction

Based on the topography and elevation contours of the greater area, groundwater is likely to flow north toward Bass Strait. A representation of likely groundwater flow direction according to changes in topography is presented as Figure 4.

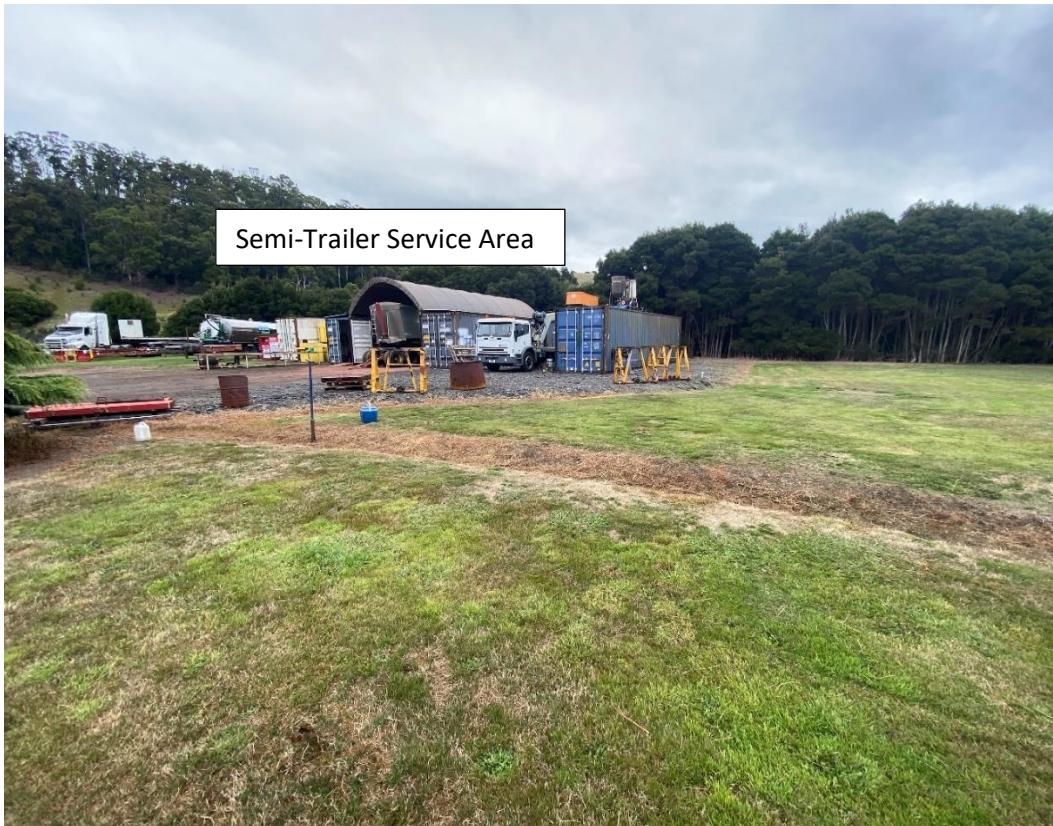
Figure 9: Storage Area

The site has not been previously developed. Prior to becoming Crown Land, it appears to have been used for agriculture. Currently the easternmost section is being used as a storage area and semi-trailer service area for an engineering workshop. No trucks or diesel-powered equipment are serviced on site. No fuel staining of the ground was observed during the site visit.

Contaminates which can be associated with workshops, similar to what is seen on the subject site, are heavy metals and petroleum hydrocarbons (TPH, TRH, PAH and BTEXN).

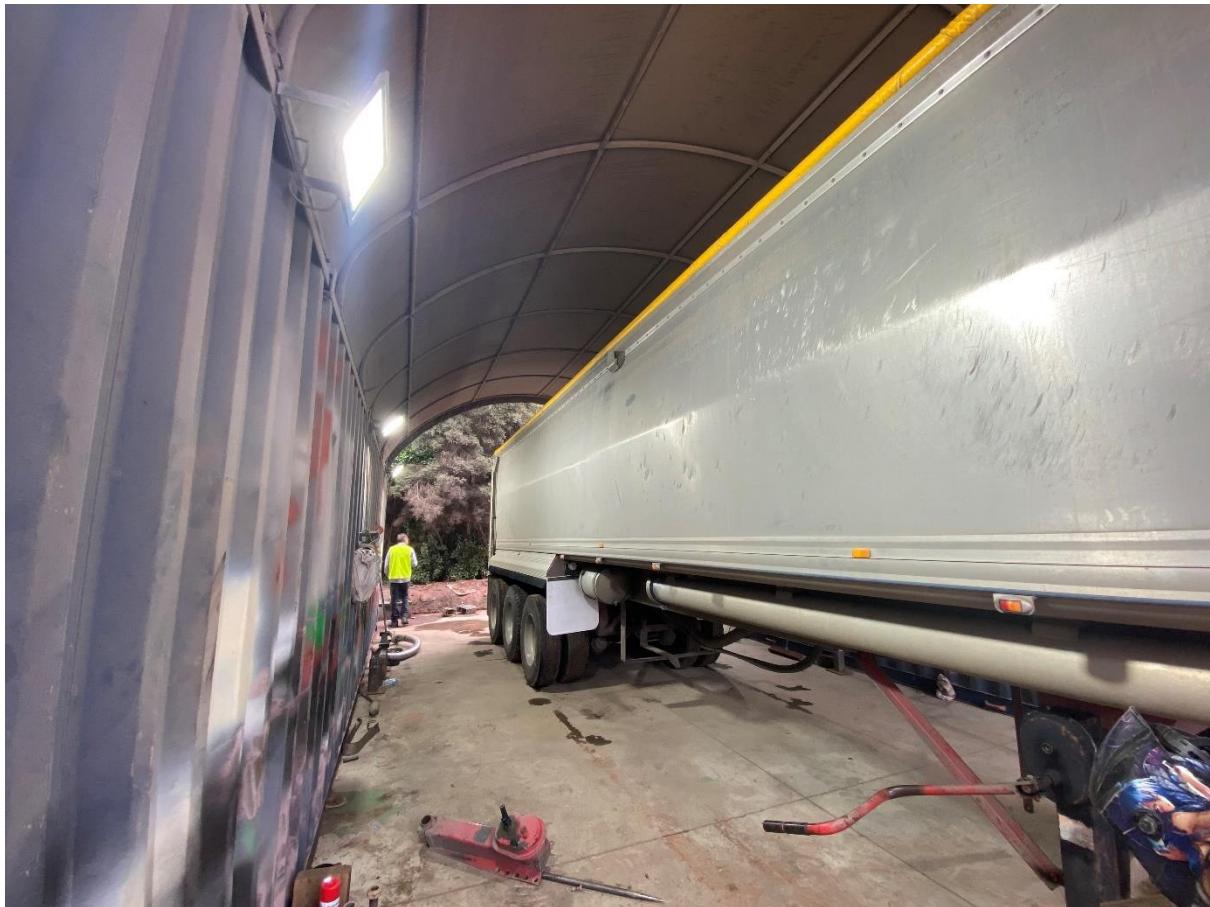
Figure 11: Inside trailer service area

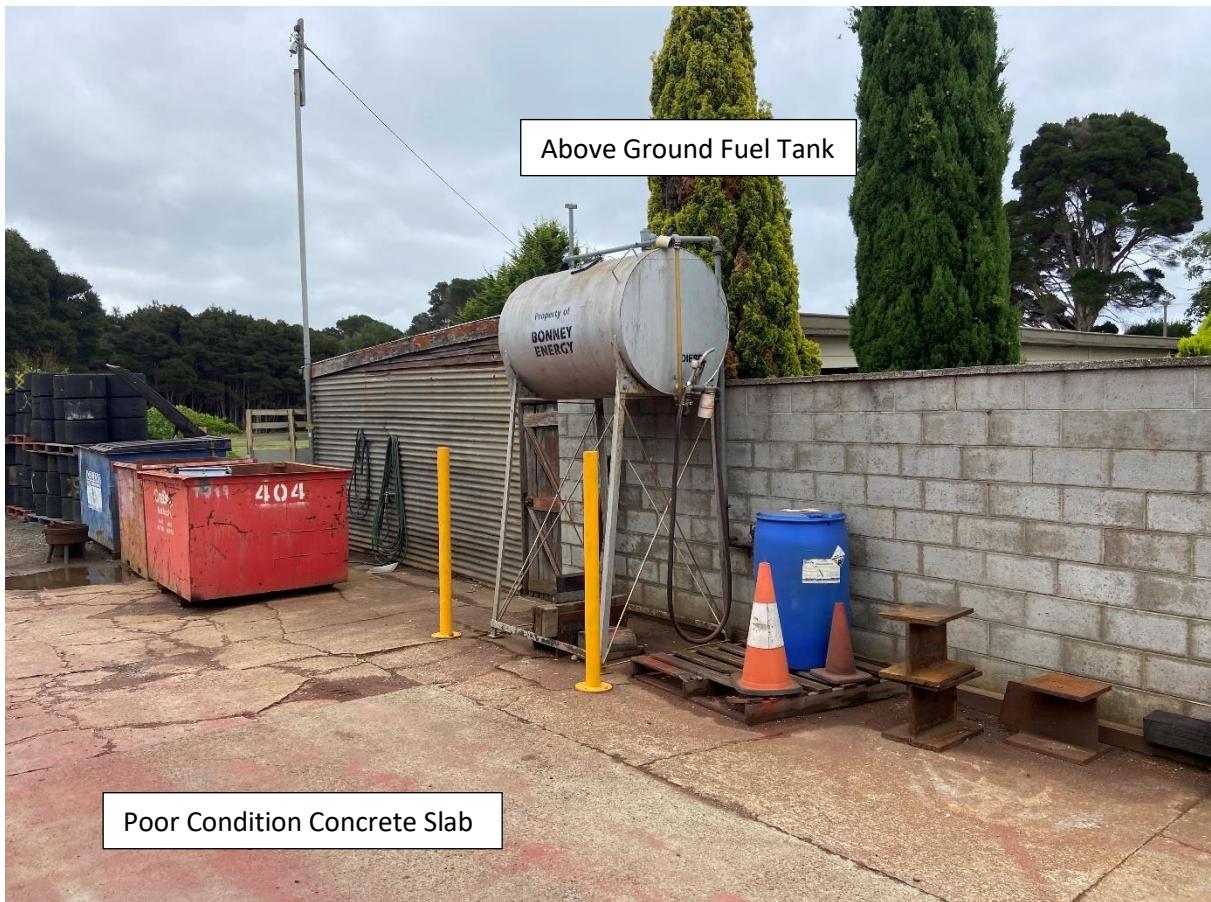
Figure 13: Fuel storage tank on broken concrete slab

Adjacent to the site is the welding and manufacturing workshop which leases a section of the site. Semi-trailers are manufactured on site and servicing of trailers is conducted next door on the subject site. No trucks or diesel-powered equipment are serviced on site. There is an above ground fuel tank and fuel trailer located on site. Concrete below the fixed standing fuel tank is in poor condition which exposes local groundwater to risk of contamination from spillage. However, there was minimal fuel staining observed on the concrete below the tank.

Contaminates which can be associated with workshops are heavy metals and petroleum hydrocarbons (TPH, TRH, PAH and BTEXN). These same contaminates also apply to fuel storage systems, such as the fuel trailer and above ground fuel tank observed on site.

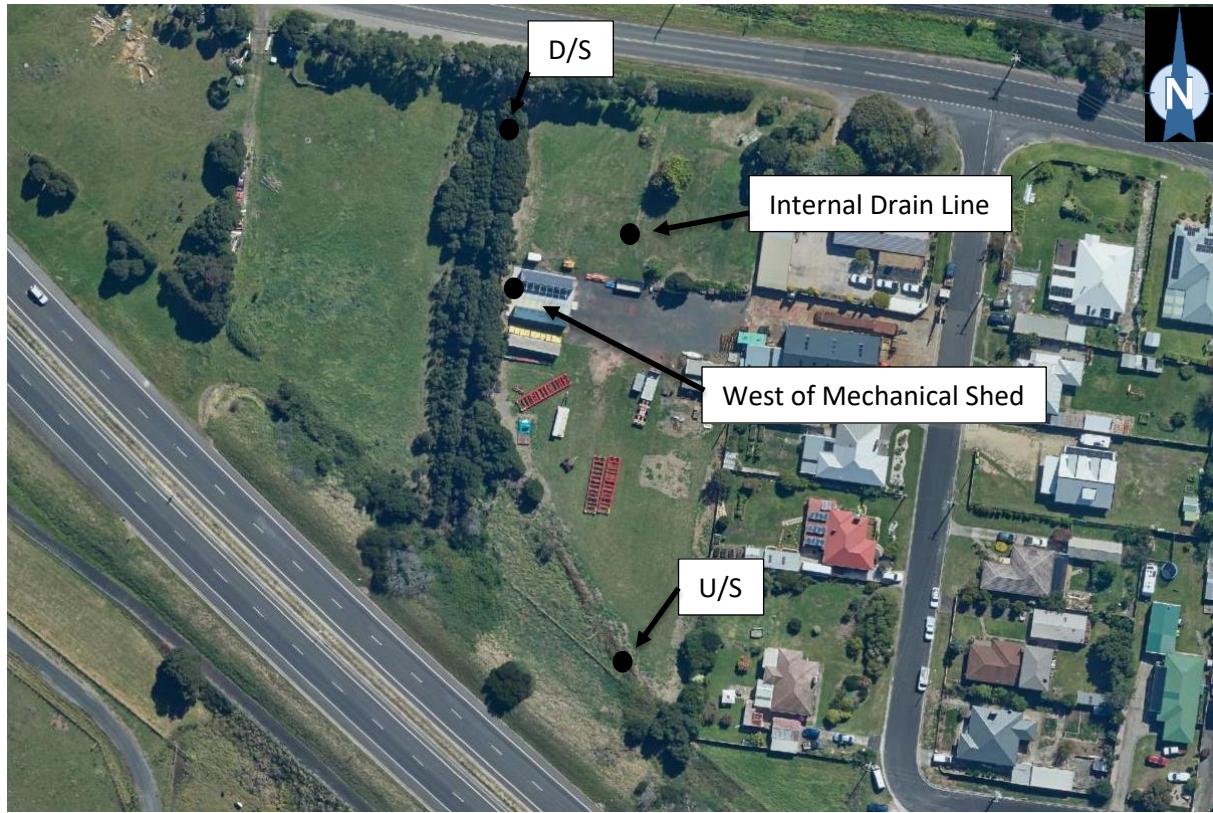
Figure 14: Sample plan

During the site visit, judgmental sampling was undertaken in four locations around the work area of the site. A field duplicate was also taken for quality assurance and quality control purposes. The sampling plan is shown below in figure 14. Results from soil sampling are shown in Table 3 and water sampling results are displayed in Table 4.

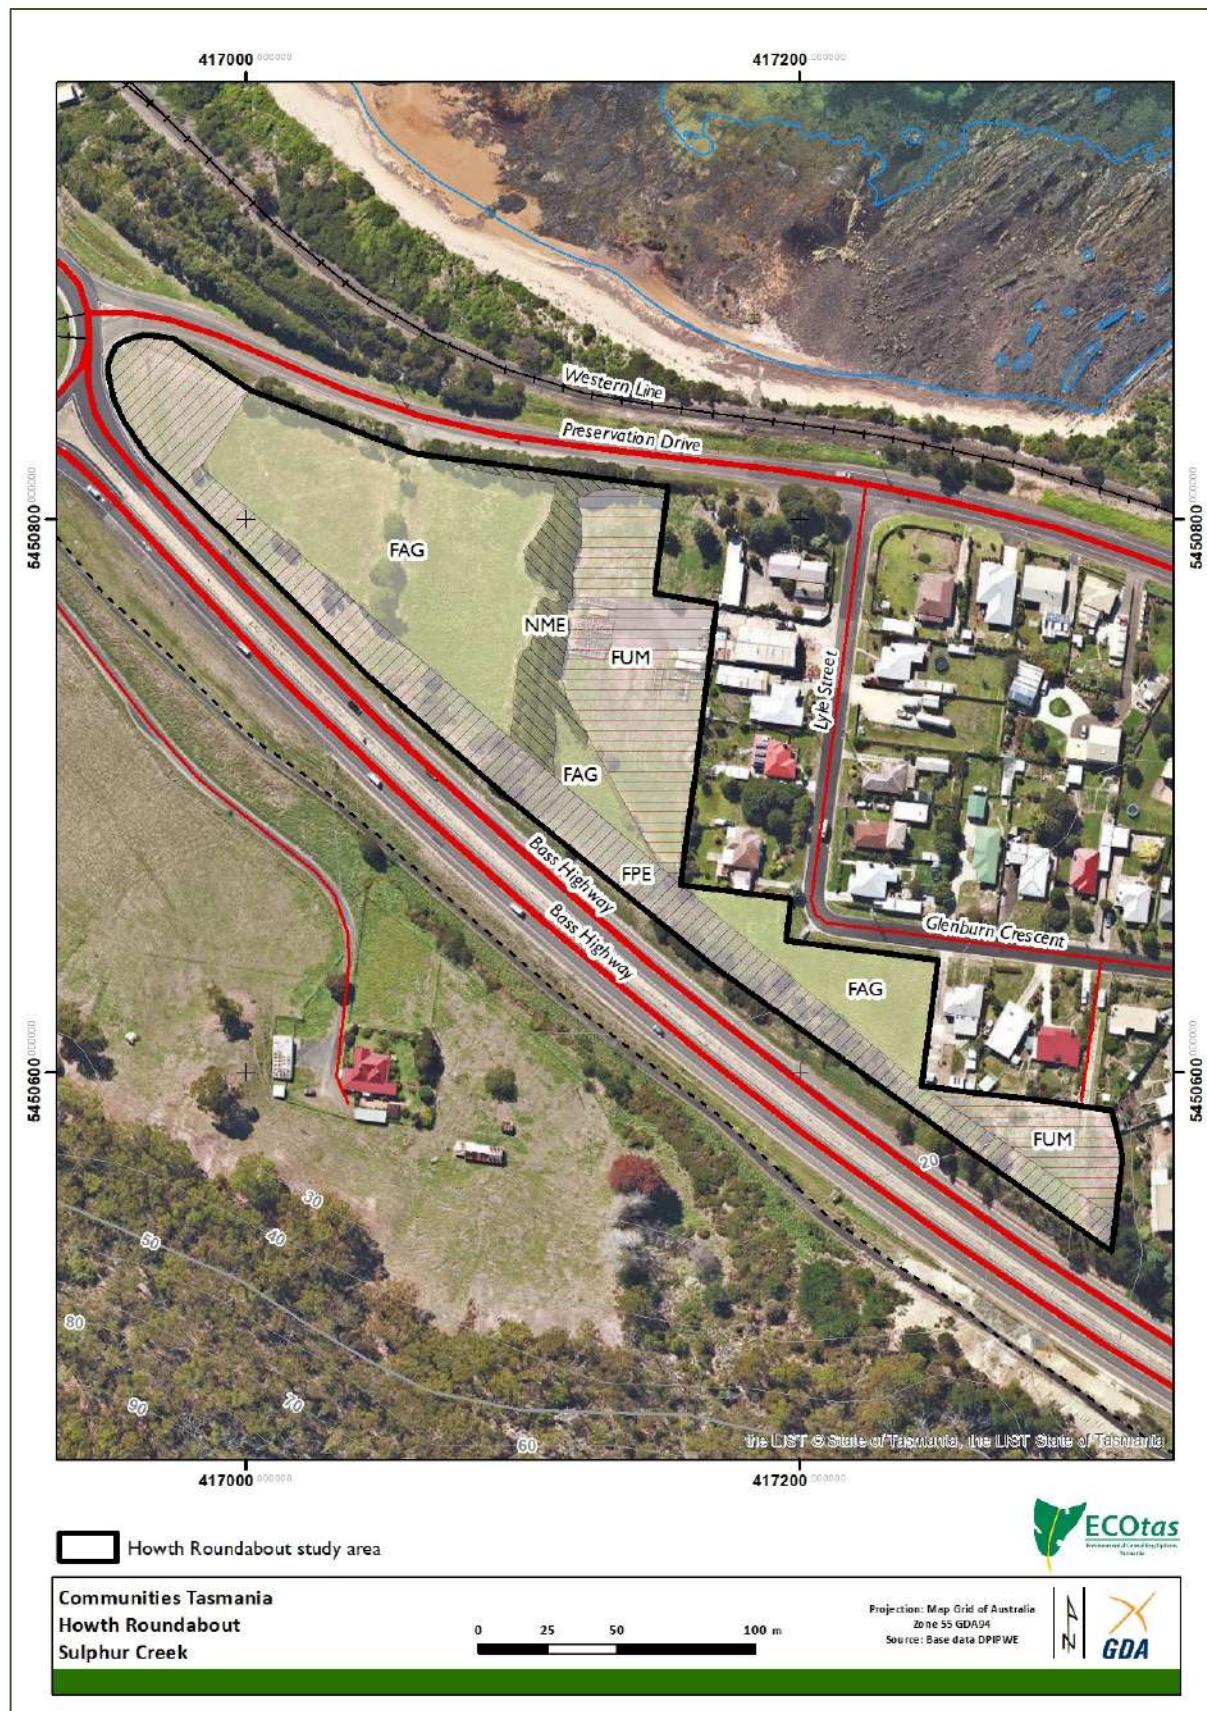
**Figure 4.** Revised vegetation mapping for the western section of the study area (refer to text for codes)

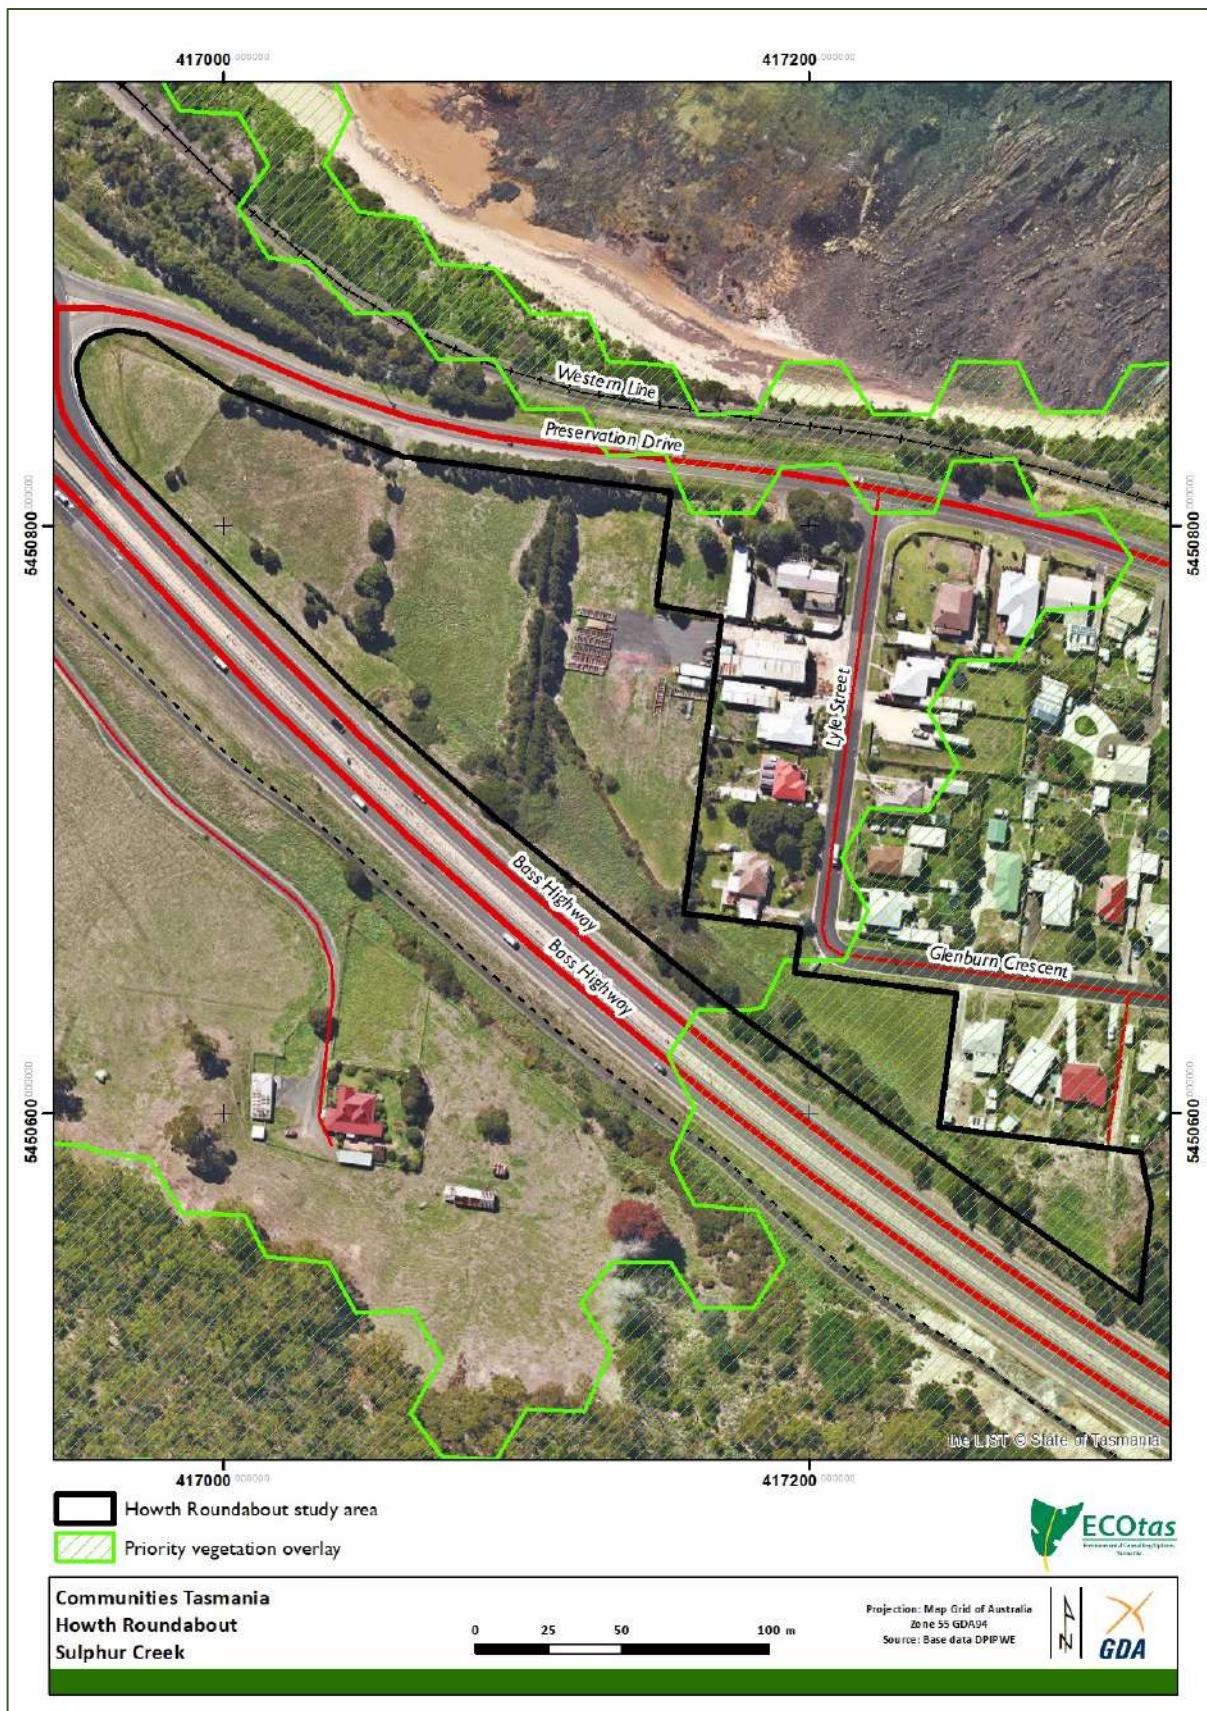
**Figure 7.** Tasmanian Planning Scheme – Central Coast Priority Vegetation Area overlay

Regarding the Priority Vegetation Area overlay (Figure 7), this area occurs in the east of the study area that is pasture, an embankment associated with the Bass Highway and a miscellaneous storage area. This overlay extends across the suburban area of Sulphur Creek including the major easement of the Bass Highway to the south. Within the study area, no native vegetation communities are present (see discussion on NME vs. FRG). The reason for the allocation of the overlay is not understood, with the recently-developed overlay based primarily on the Regional Ecosystem Model, in turn based on TASVEG 3.0 vegetation mapping (which did not indicate any native vegetation present).

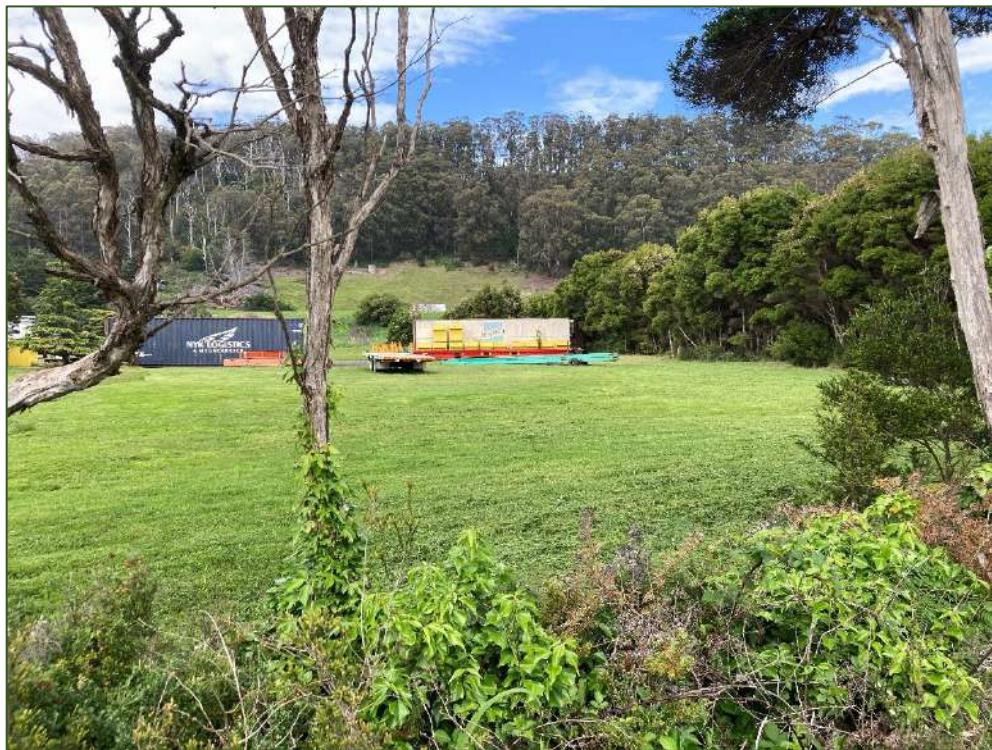
**Plate A3.** View south with FUM in the foreground and FRG along the drain in the right of the image

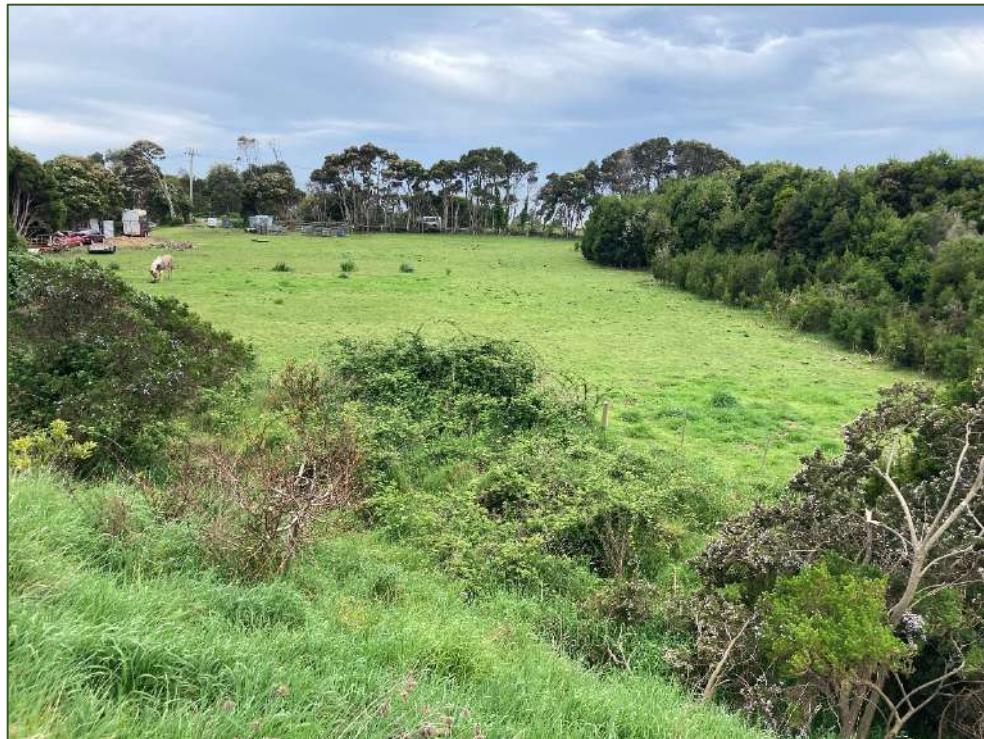
**Plate A4.** FAG in the west with weeds dominating the highway embankment in the foreground and *Melaleuca ericifolia* invading the drain on the right

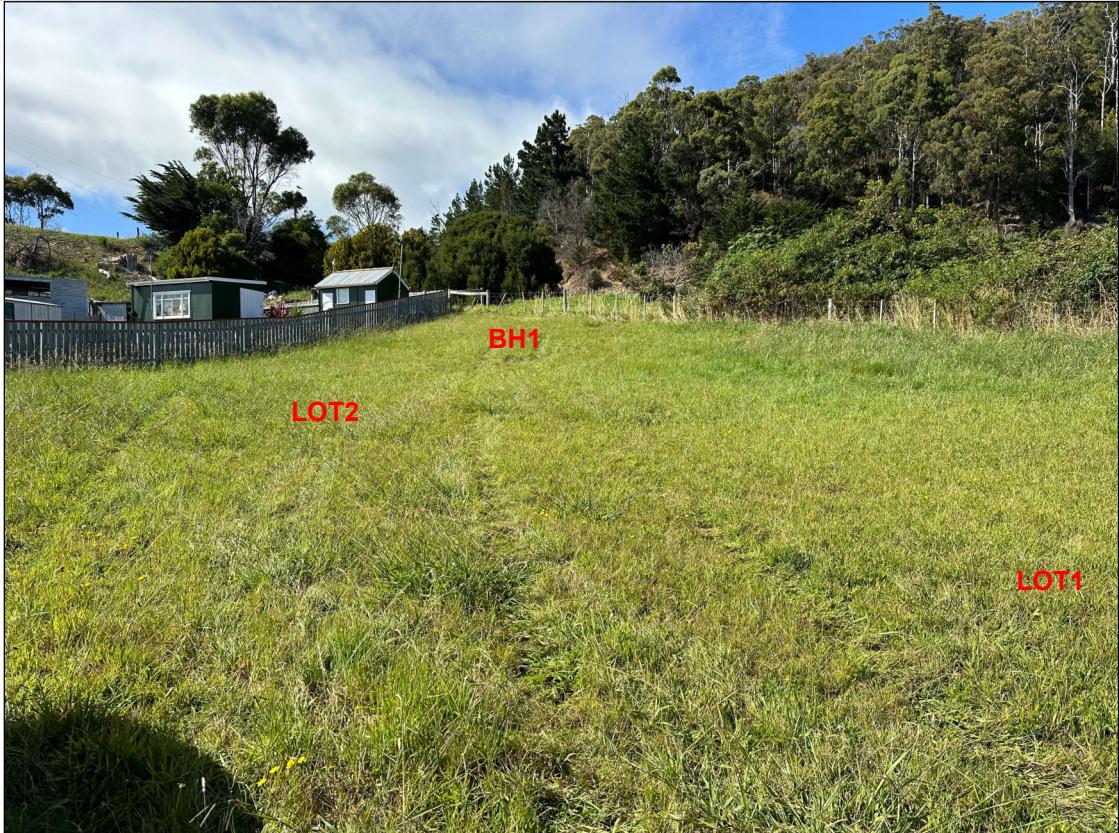
PLATE 1 - View of Lot 1 and Lot 2 looking to the southeast

Lot 3 generally has a steep slope up towards northwest of between 12° and 25° (see Plate 2 and Plate 5). Lot 3 has been altered by past fill earthworks across the site. A steep fill batter slope is located along the proposed driveway for Lot 3 (see Figure 6 and Plate 4). A road cut batter is located parallel to the southern boundary of Lot 3 (see Plate 3 and Plate 5). The road cut batter consists of insitu bedrock overlain by a thin topsoil layer.

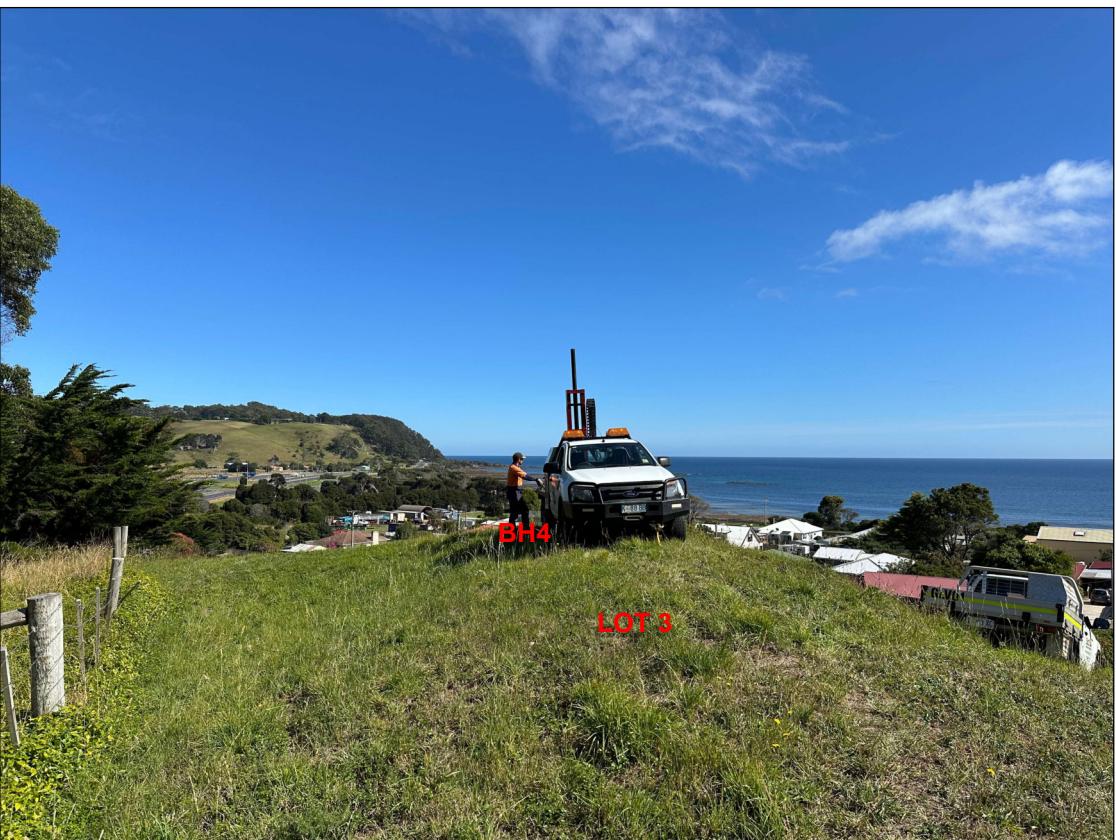
PLATE 2 - View of Lot 3 looking to the west

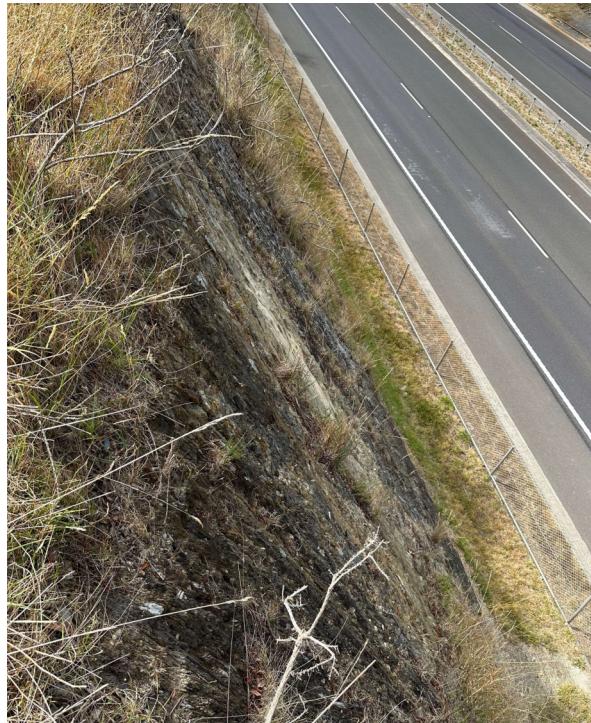
**PLATE 3 - View of the road cut batter below Lot 3 along Bass Highway. Cut batter consists of insitu bedrock with a thin topsoil layer**

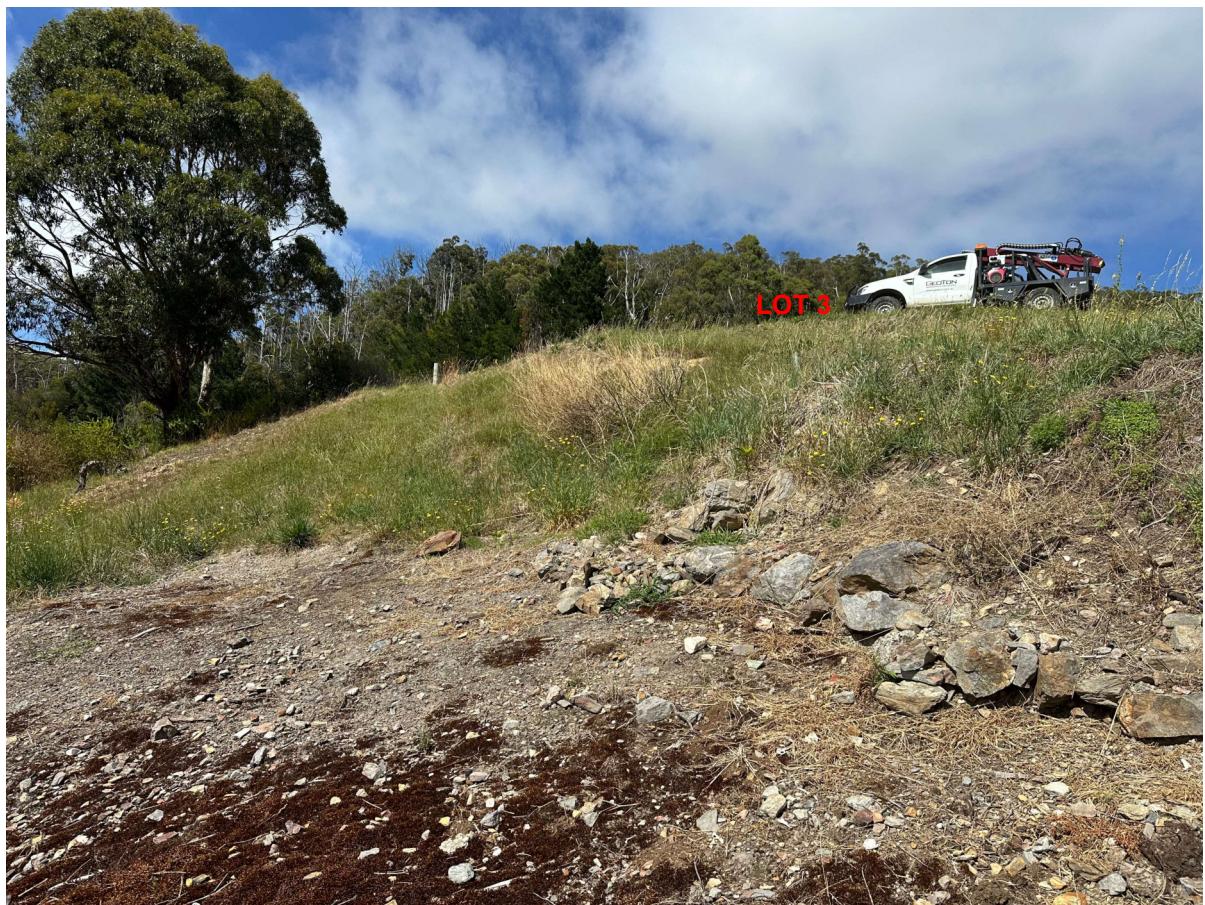
**PLATE 4 - View of the fill batter within the eastern portion of Lot 3, looking to the west**
