# Planning Submission

## Housing Land Supply Act

### Preservation Drive, Sulphur Creek

The following submission has been prepared by All Urban Planning Pty Ltd for Homes Tasmania in support of a housing land supply order under the *Housing Land Supply Act 2018* (HLSA). The proposed order is to rezone an area of land (the subject land) at Sulphur Creek, adjacent to the Howth roundabout from Utilities zoning to General Residential under the *Tasmanian Planning Scheme – Central Coast Local Provisions Schedule (planning scheme)*.

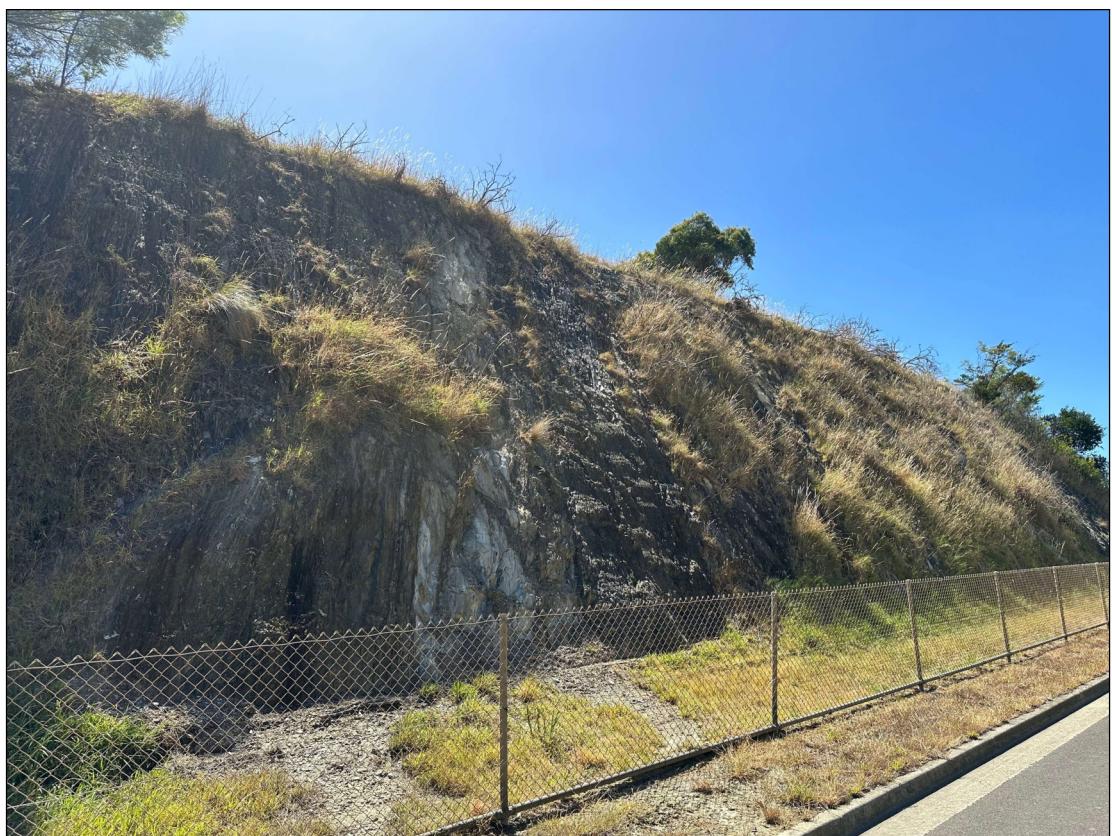
PLATE 6 - View of the cut batter below Lot 3 from Bass Highway, looking to the northeast

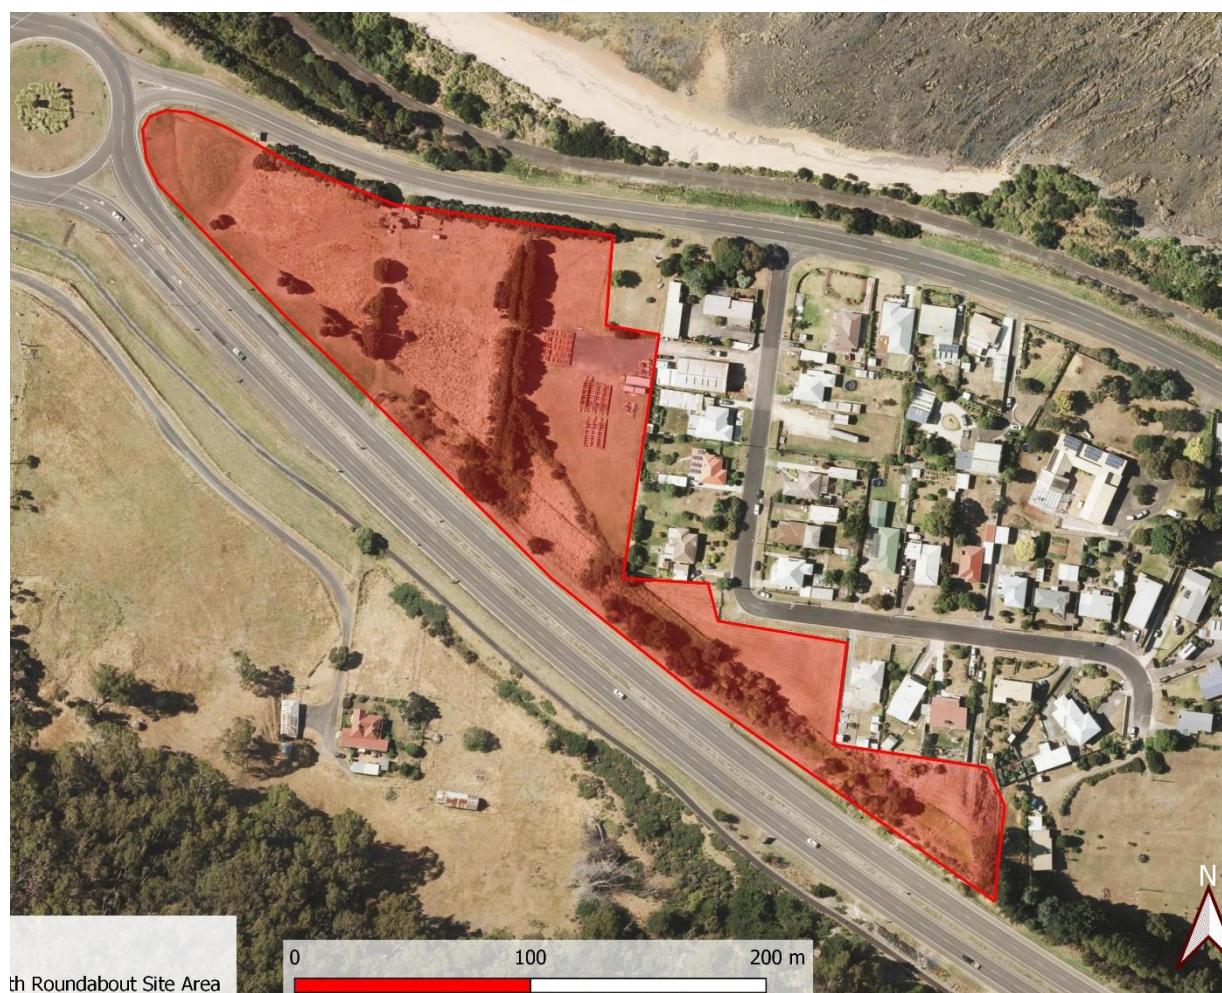
The land is relatively flat across most of the study site at 5-8 mAHD, before a slight inclination towards a small hill of 30mAHD behind the properties on the southern side of Glenburn Crescent. There is a natural depression on the western-most point of the study area next to the roundabout.

**Figure 1. Roundabout at Bass Highway and Preservation Drive, Sulphur Creek**

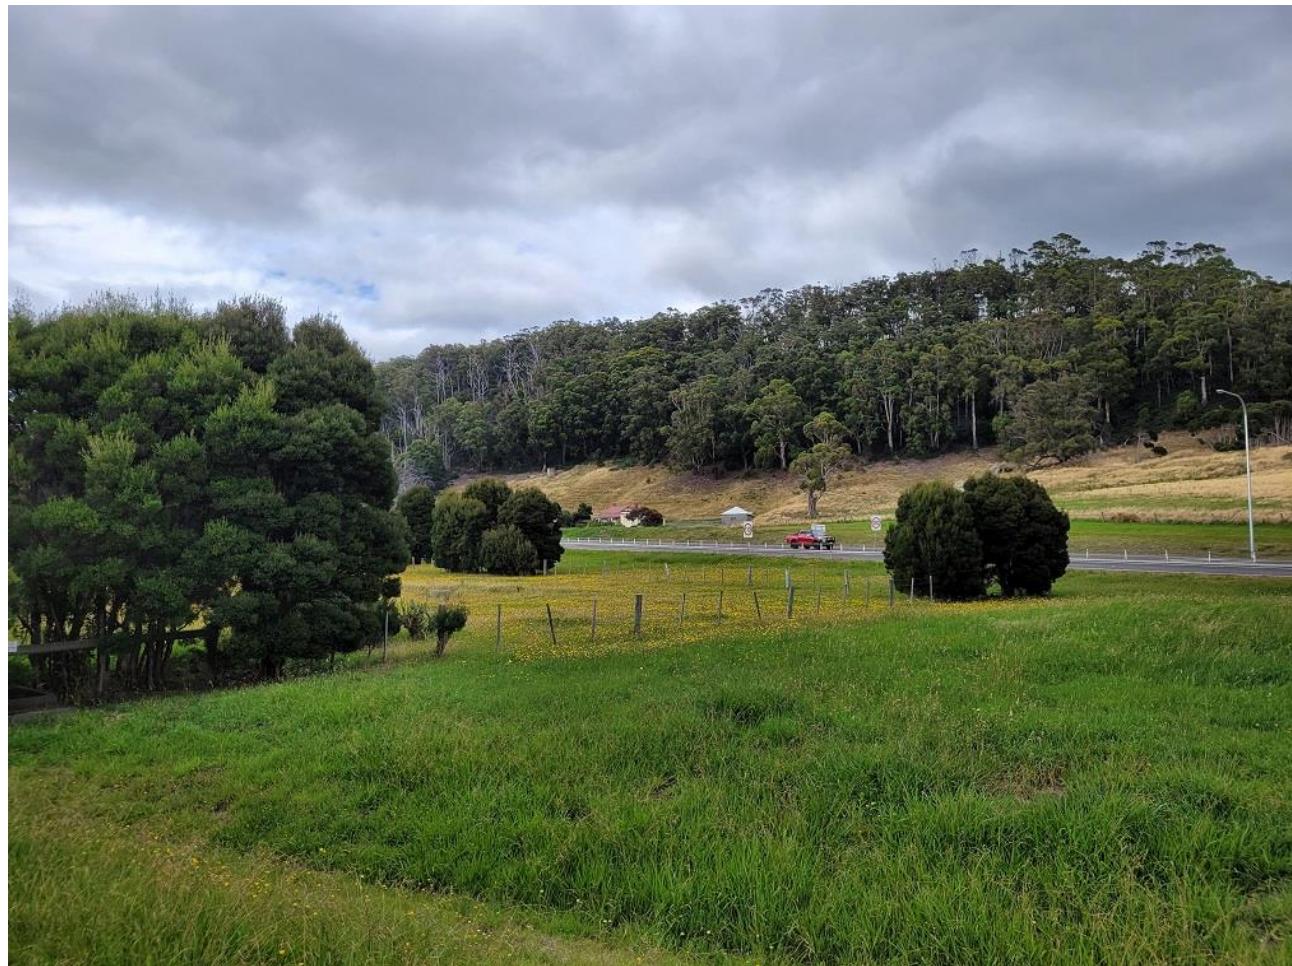
Along the length of the study site adjacent to the highway is mostly flat until a small hill is reached in the eastern most point of the study site behind Glenburn Crescent. A view of the study site from the roundabout looking south-east towards the Bass Highway is shown in Figure 2 and is indicative of the low-lying areas.

**Figure 2. South-east facing Bass Highway from the roundabout**

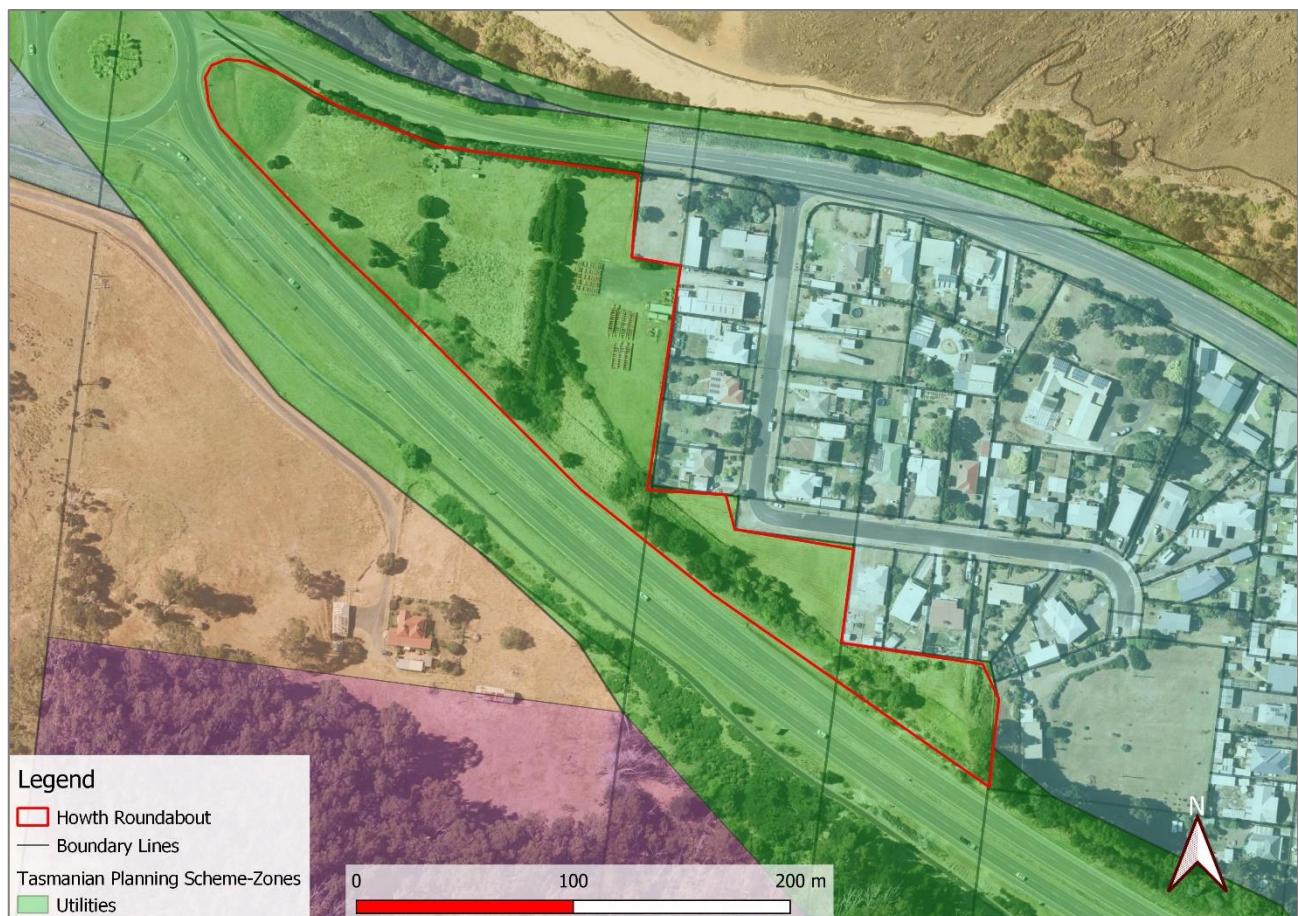
The entire study area is zoned as Utilities, but the area immediately to the east is zoned General Residential Figure 3. The area to the south of the Bass Highway is zoned Rural. The zones are shown in Figure 3.

**Figure 3. Tasmanian Planning Scheme Zones**

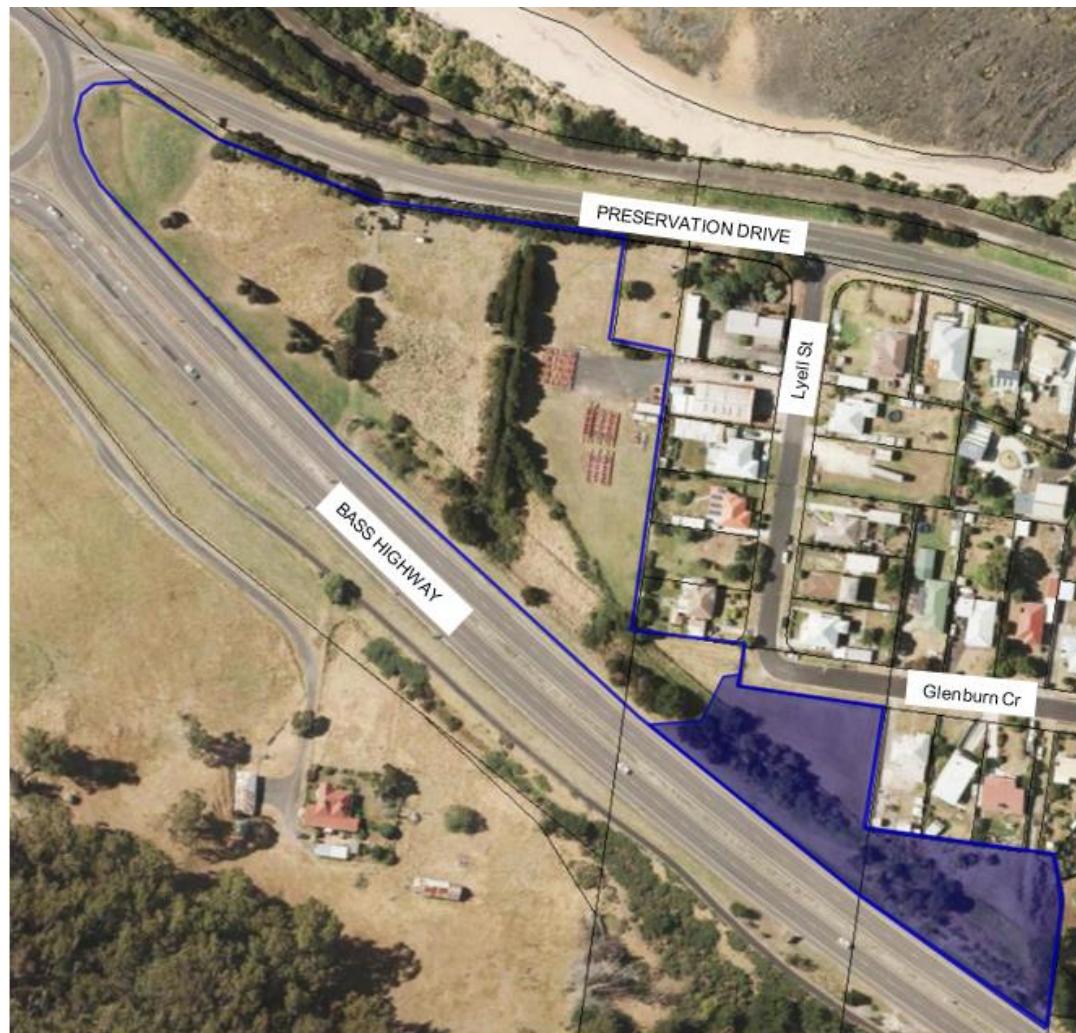
**Figure 4. Natural Assets Code Overlay (blue shaded)**

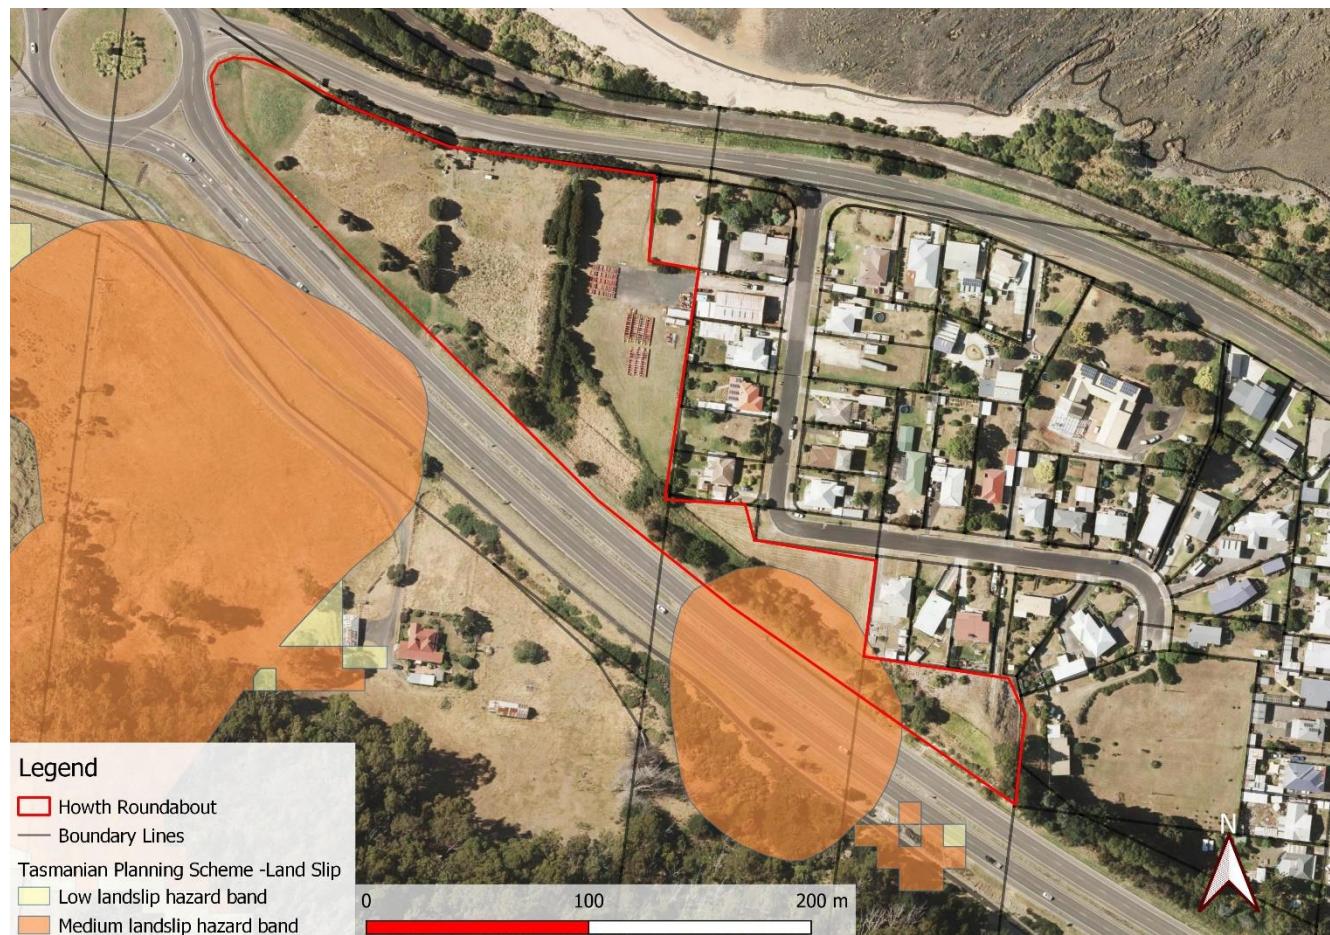
**Figure 5. Landslide hazard bands (DPAC)**

Excavation and construction in a medium landslip hazard category should be avoided and any works in a low category should be monitored over the construction period and permanent mitigation measures must be designed and constructed to prevent future landslip failures.

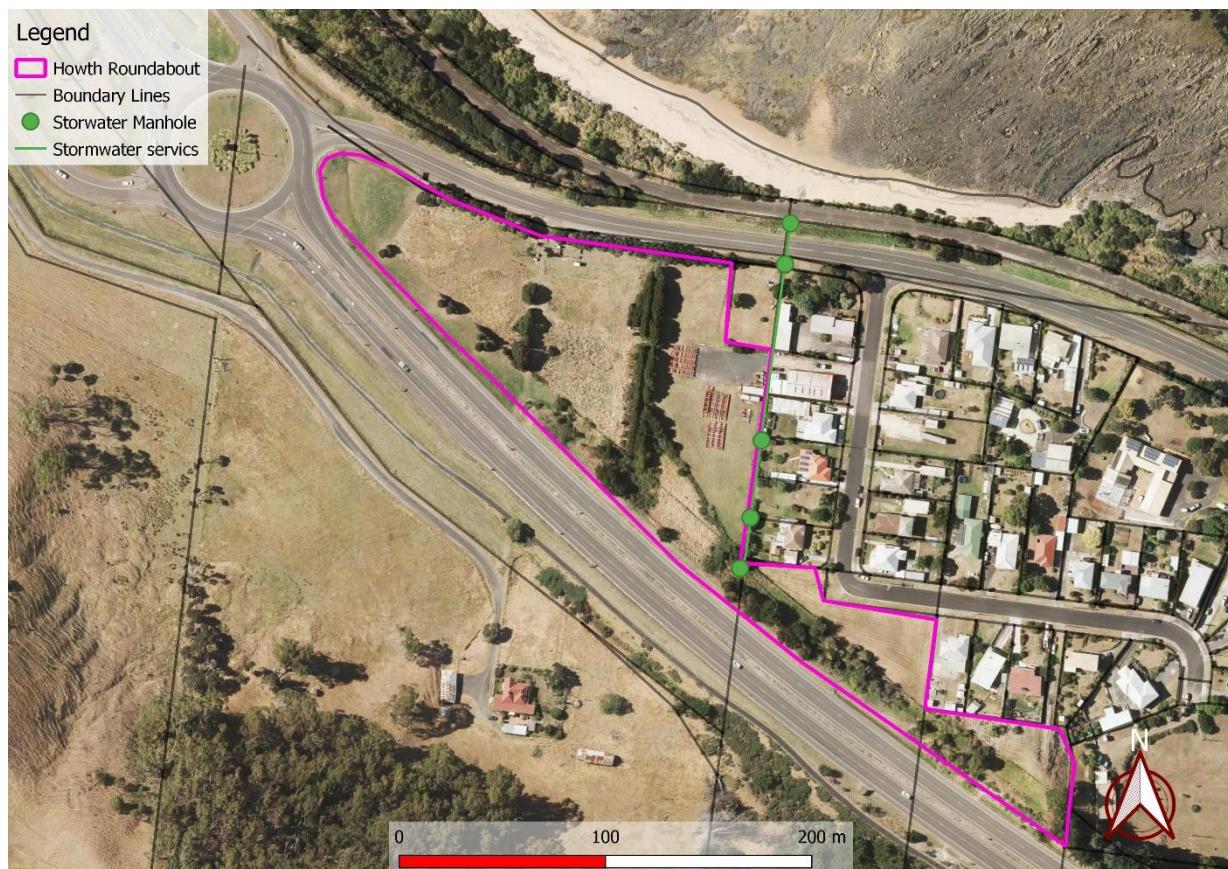
**Figure 6. Current stormwater services at Preservation Drive**

- major stormwater system be designed to accommodate a storm with an ARI of 100 years; and,
- minor stormwater system be designed to accommodate a storm with an ARI of 20 years.

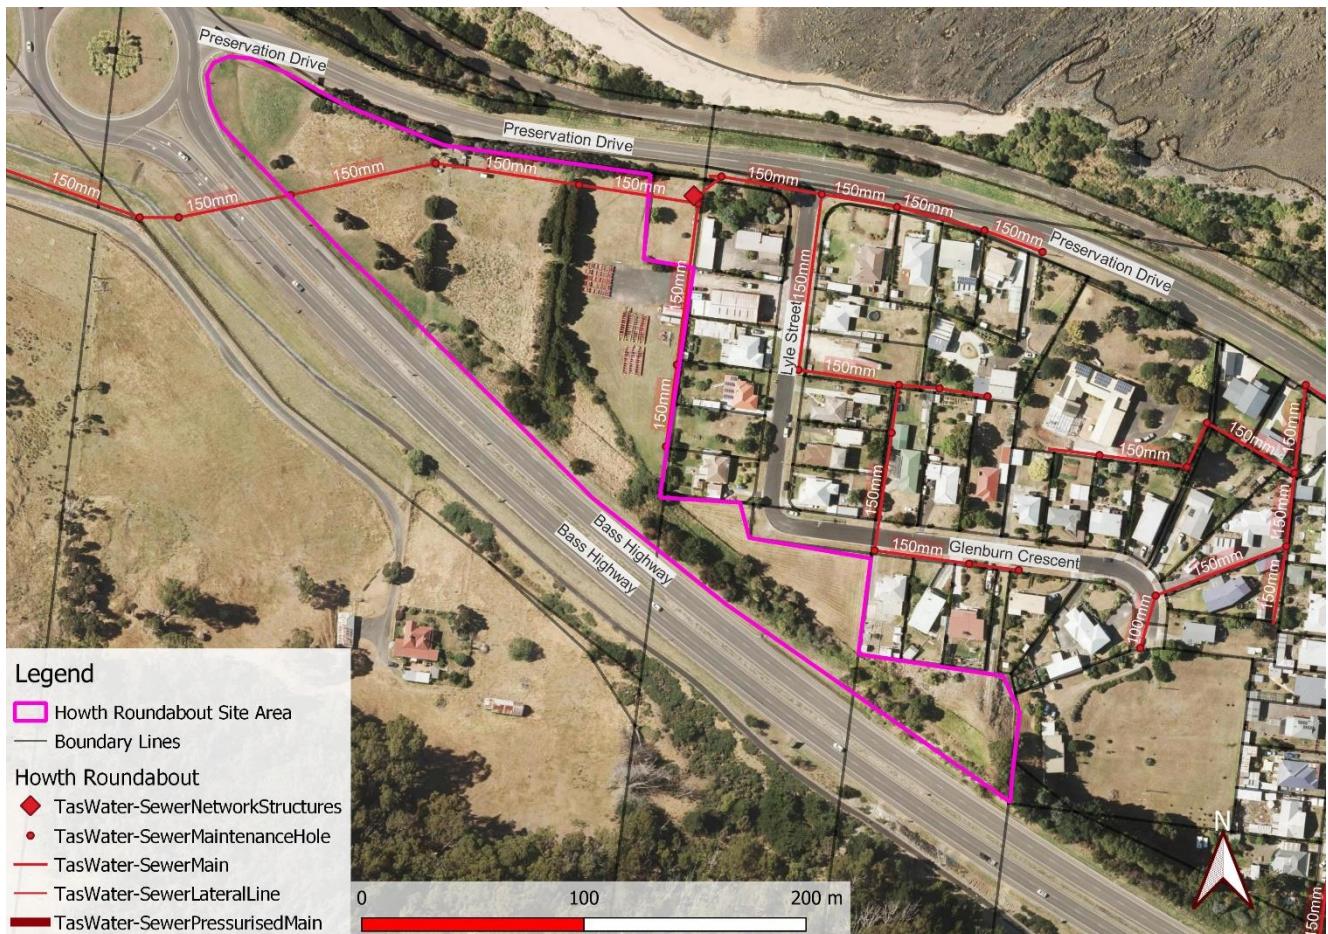
**Figure 7. Current sewer network in the vicinity of the Howth Roundabout study area.**

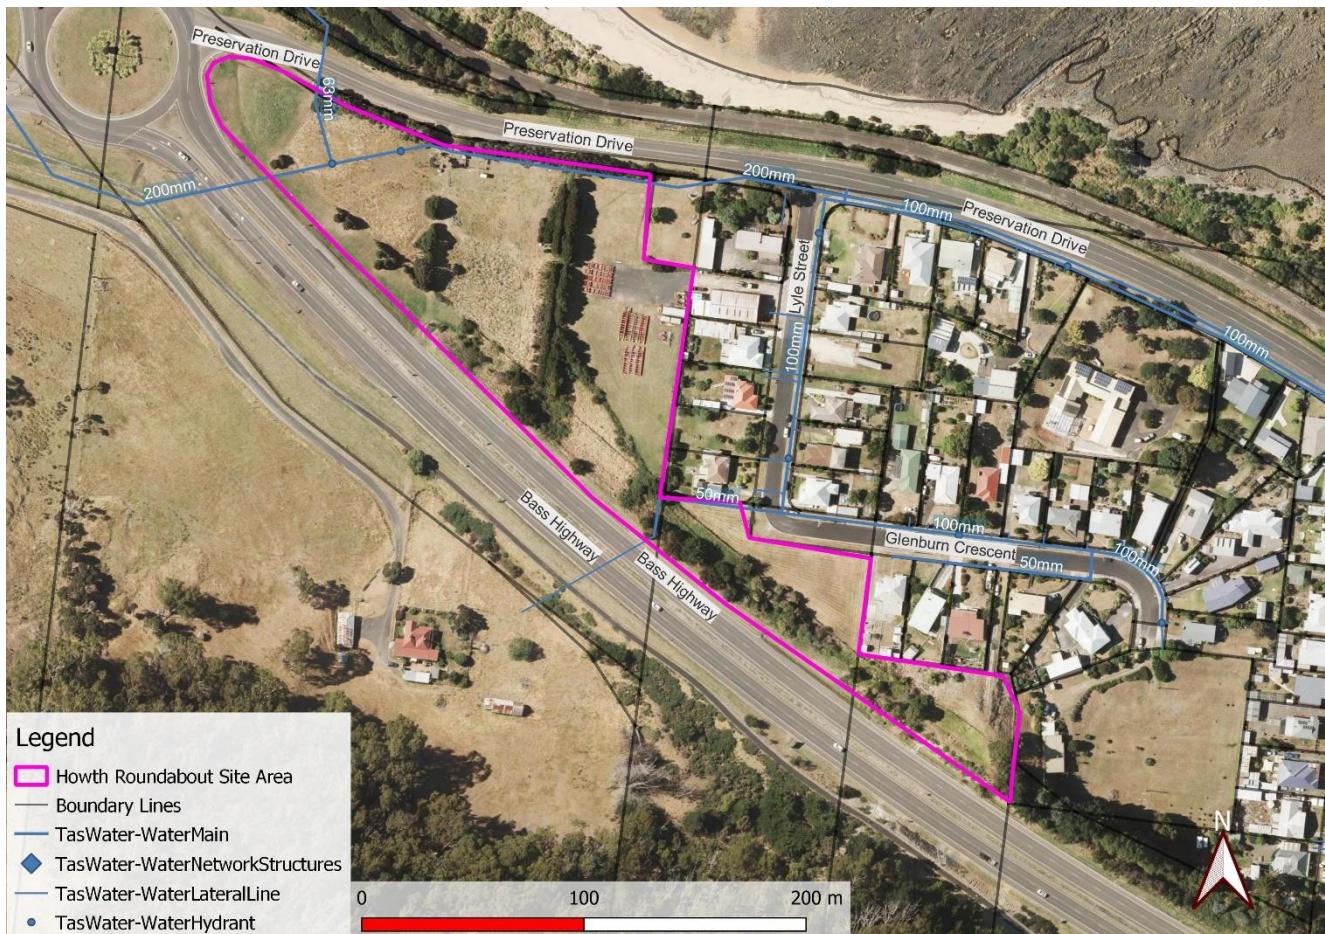
**Figure 8. TasWater network structures through and in the vicinity of Howth Roundabout study area**

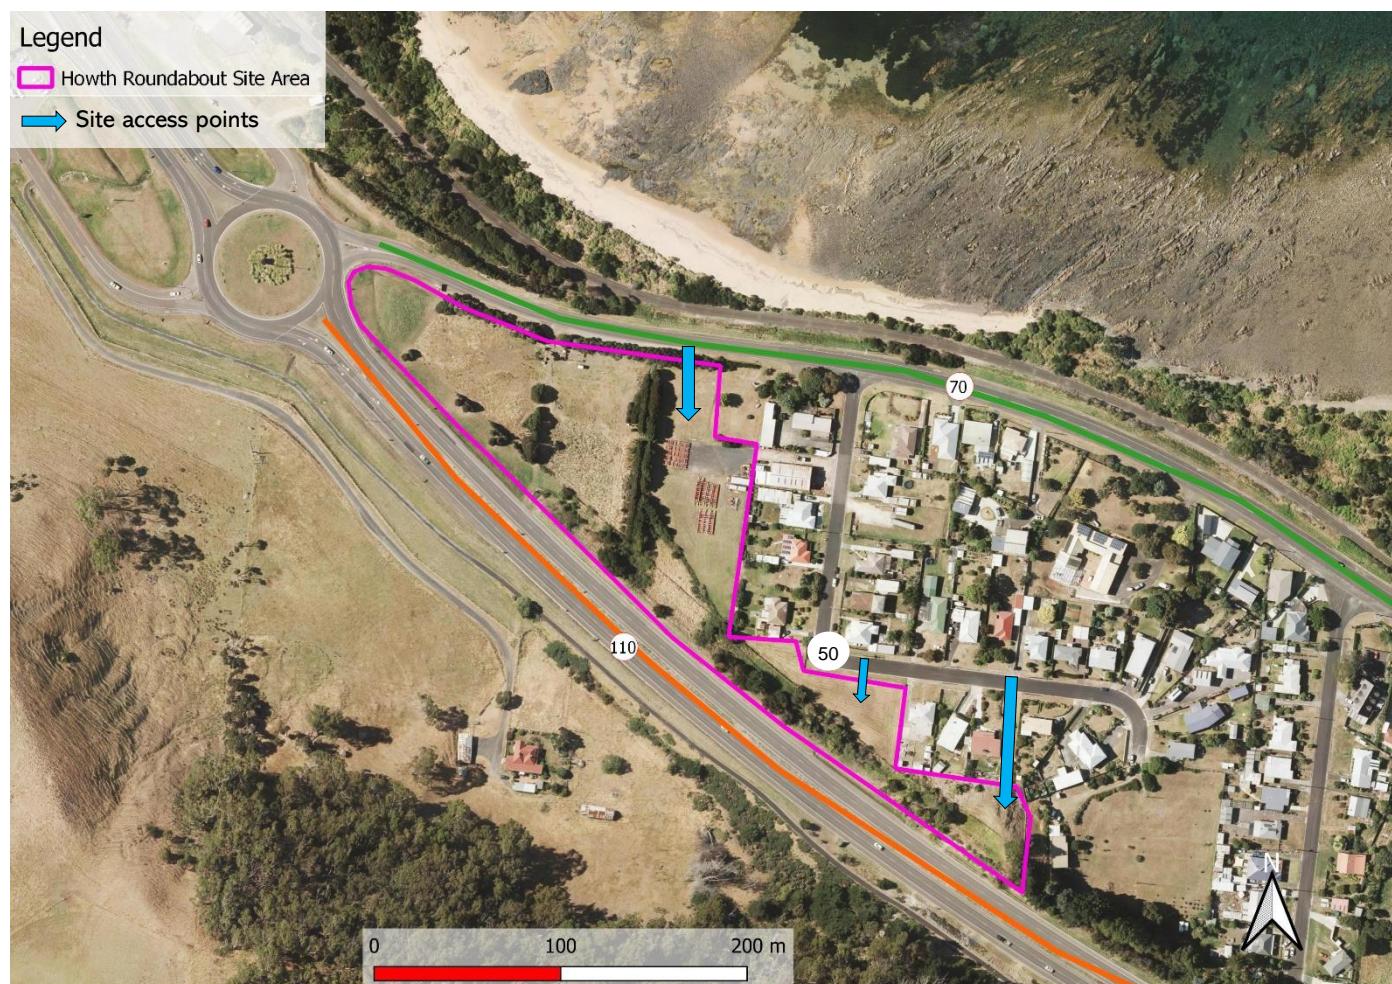
There is a right of way of Glenburn Crescent that accesses the land at the eastern boundary of the study site. This could be utilised as a driveway for a single lot in this area. The three potential access points are shown in Figure 9.

**Figure 9. Howth Roundabout study site surrounding speed limits**
